**ARTICLE****Initiation Mechanism of Transverse Cracks in Wind Turbine Blade Trailing Edge**Jinghua Wang¹, Leian Zhang¹, Xuemei Huang^{1,*}, Jinfeng Zhang² and Chengwei Yuan¹¹School of Mechanical Engineering, Shandong University of Technology, Zibo, 255049, China²China General Certification Center, Beijing, 100013, China

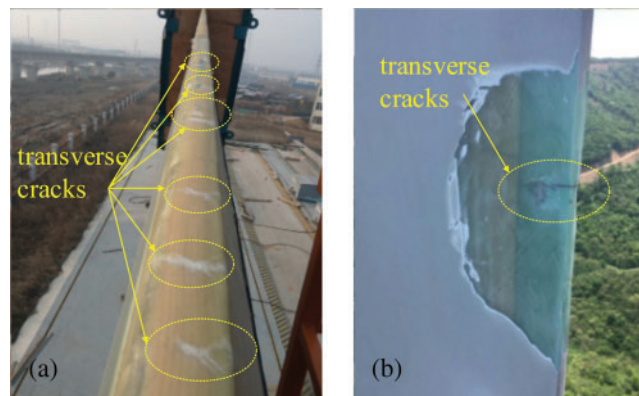
Based on previous research, blade manufacturers noticed that the transverse crack defects (Fig. 1a) are often generated in the blade trailing edge after a large number of fatigue tests. Similarly, the blade operating on the wind turbine tower is often damaged by cracks before reaching its design life (Fig. 1b). The blade trailing edge is a shell structure bonded by adhesive. In the middle and leading segment of the blade shell, there are only 2–6 multiaxial GFF layers, which is a little weak. Due to the poor capacity of fatigue performance of bonding structure, it is damage easily when loaded by fatigue forces. Then stress concentration would be caused in the adhesive of trailing edge, making the trailing edge strength decrease and cracks easily.

Figure 1: Cracks defect in the blade (a) Defective blade in fatigue test, (b) Defective blade in wind turbine tower

There are two methods to avoid the transverse crack in the trailing edge: 1. Redesign the bonding paste of the trailing edge and reasonably determine the adhesive thickness in the blade production. 2. Adding GFF crack control layer in the laminate, which can reduce the stress concentration and improves the fatigue strength of the trailing edge. In the latest blade design, an anti-cracking layer is added to the shell at the trailing edge. After the blade fatigue test, there is no transverse crack on the trailing edge.

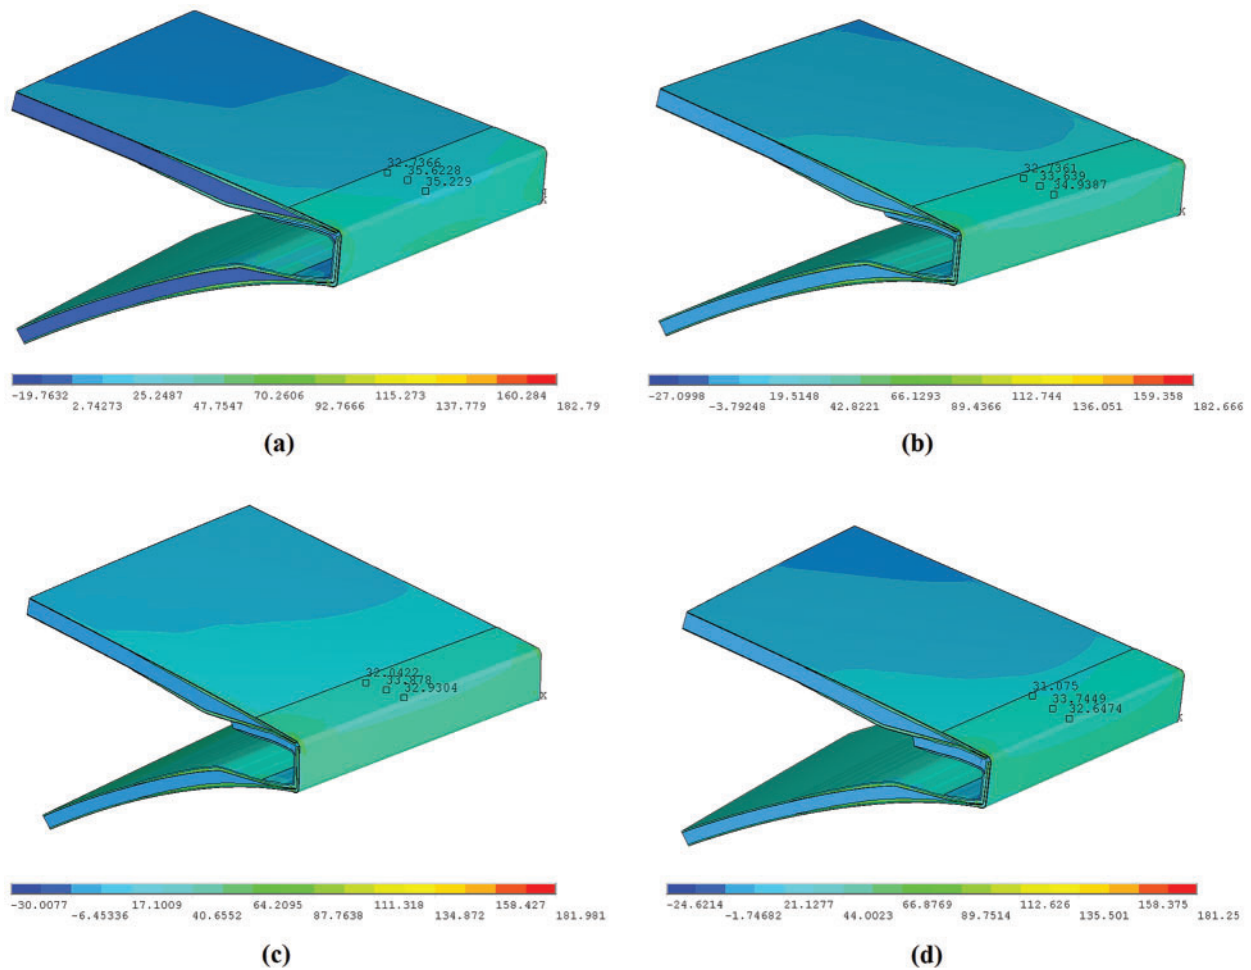
By establishing the trailing edge model with different bonding thicknesses, the local stress distribution of the adhesive joint with a crack at the trailing edge is simulated, respectively. Finally, a reasonable explanation is given. It can be seen from Fig. 6 that: the laminate crack causes stress redistribution in the crack region of the blade trailing edge, and different bonding parameters lead to different stress distribution. The stress concentration factors of adhesive joint models with different thicknesses are obtained by extracting the element stress in the crack region, see Table 1. The stress concentration factor is cited in the fatigue analysis of the blade trailing edge. Then the fatigue strength of the GFF material is calculated referring to the Markov matrix of the blade. In final, the influence of eigenvalue λ on the fatigue results of the trailing edge is collected under different stress concentration factors.

K_t represents the level of stress concentration of the crack regions. It can be seen from Table 1 that the stress concentration factor K_t and λ have a noticeable increase with the adding of adhesive thickness. It indicates that the stress contribution factor of bonding paste in global structure performance increases with adhesive thickness. The bonding paste absorbs a larger fatigue load when has a thicker adhesive. Simultaneously, laminate with cracks will release more stress and transfer to the surrounding laminate so that the adhesive joint can obtain a higher stress concentration factor, which makes the shell more prone to fatigue cracks.

The FE results show that when the bonding paste thickness adds, the fracture will cause a more serious local stress concentration, which makes the trailing edge shell has a higher probability of fatigue failure and transverse cracks. And the actual production shows that when the bonding paste is too thick in production, it is easy to produce internal stress and cavity defects in the curing process, which makes the bonding paste has a poor performance and fatigue

Figure 6: Simulation results of adhesive joint with different bonding paste thickness (a) With thickness 2 mm, (b) With thickness 6 mm, (c) With thickness 10 mm, (d) With thickness 15 mm

strength. Therefore, better control of bonding paste thickness in its production is conducive to improve the strength of the trailing edge.

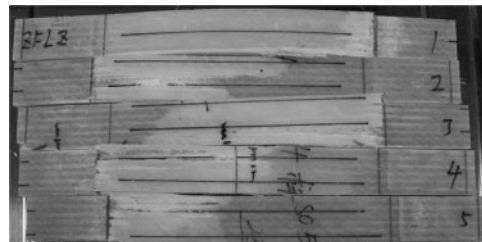
The static loading results of the sample are shown in Fig. 8. The ultimate strength values of the specimens measured by the test are 121/114/120/140/133 MPa in Fig. 9, with an average of 123.6 MPa.

Figure 8: Fracture behavior of the specimens in static test

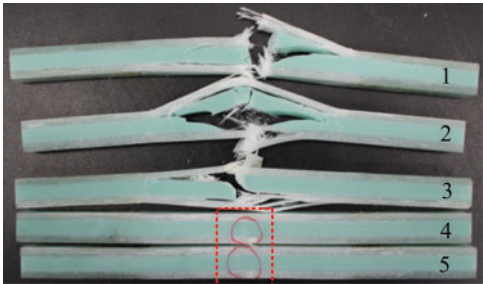
In the fatigue test, the maximum value in the load spectrum is set as 40/50/60/80/100 MPa. The cyclic load was applied to the specimens with a stress ratio of 0.05 and a frequency of 1.02 Hz until it fails, and then the S-N data of the specimens are collected. The failure modes include laminate damage and adhesive crack in Fig. 10. More serious damage was done to the specimens when subjecting to the larger cyclic load, as shown in Fig. 11. The regions marked in Fig. 10 suffered minor damage at the time of failure. The S-N curve fitted according to the test results is linear, the fitting curve can express as $y = 177.17x - 0.118$.

Figure 10: Fracture behavior of the specimens in fatigue test

Macroscopic observation of the test process shows that the initial cracks are always generated in adhesive under fatigue load. The stress concentration occurs around the crack region, which caused the crack extension of adhesive. In the crack extension process, the laminate on both sides of the crack is also damaged due to adhesive structure defects. The crack in laminate extends laterally, which reduces the global structural performance of the blade.
