Low-Velocity Impact Response of Braided Carbon/Epoxy Composites

M.V.Hosur¹, M. M. Islam and S. Jeelani

Summary

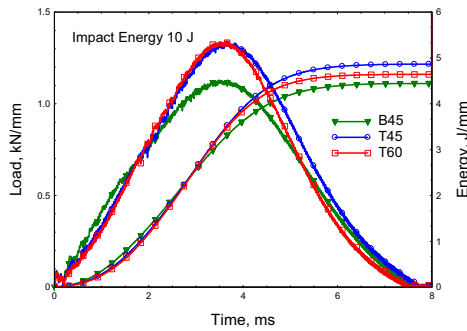
Figure 1: Impact response of braided composites at 10 J

Figures 1-3 illustrate typical impact response plots in the form of load-time and load-energy response of the laminates at 10, 20 and 30 J respectively. Under the impact load, laminates respond elastically at low energy levels. As long as the energy is well within a certain threshold value, the response will continue to be elastic and is well captured in the impact response plots as seen in Fig. 1. The loading and unloading curves are smooth and symmetric about the peak load. So, at 10 J all the three types of fabric configurations studied here show elastic response without any damage. When the energy values exceed the threshold energy, the laminates absorb the energy through elastic deformation as well as through creation of damage since composites are inherently brittle in nature. The initiation and growth of damage causes the local stiffness to decrease and is indicated in the load-time plots by the drop in the load as seen in Fig. 2. When the damage initiates there will be drop in load which again picks up as the load gets distributed to the neighboring fibers. The level of load drop also indicates qualitatively the severity of the damage as seen in Fig. 3. In this study, energy absorbed by the braided laminates was calculated as the difference in the energy at the end of impact event and that corresponding to the peak load. It was assumed that the energy up to the peak load is absorbed in the form of elastic deformation. Since the laminates varied slightly in thickness, impact parameters like peak load and absorbed energy were normalized for thickness. The normalized load at 10 J for $\pm 45^\circ$ biaxial laminates was 1.12 kN/mm

and was 1.33 kN/mm for $0^\circ/\pm 45^\circ$ and $0^\circ/\pm 60^\circ$ laminates. The absorbed energy was 1.30, 1.32 and 1.29 J/mm respectively. The normalized load at 20 J was 1.78, 1.98 and 1.79 kN/mm for $\pm 45^\circ$, $0^\circ/\pm 45^\circ$, and $0^\circ/\pm 60^\circ$ laminates respectively. The absorbed energy was 2.66, 2.63 and 3.84 J/mm respectively. The normalized load at 30 J was 1.90, 2.02 and 1.95 kN/mm respectively for $\pm 45^\circ$, $0^\circ/\pm 45^\circ$, and $0^\circ/\pm 60^\circ$ laminates. The absorbed energy was 5.91, 6.17 and 7.26 J/mm respectively. From these values, it is inferred that triaxial laminates absorb more energy and also sustain relatively higher loads than the biaxial laminates. The increased energy absorption and the load carrying capability can be attributed to the presence of 24k fiber tow along the longitudinal direction. Though, the presence of extra tow makes the in-plane properties lower for triaxial fabrics than that of the biaxial, the mere presence of the longitudinal fiber tow allows them to carry extra flexural tensile stresses resulting from the impact event. Among the triaxial fabrics, $\pm 45^\circ$ tows offer higher in-plane properties when compared with $\pm 60^\circ$ tows, although $\pm 60^\circ$ tows offer a quasi-isotropic in-plane conditions.

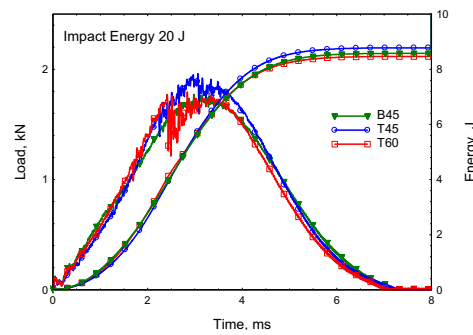
Figure 2: Impact response of braided composites at 20 J

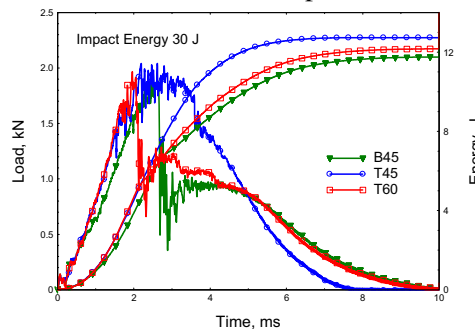
Figure 3: Impact response of braided composites at 30 J

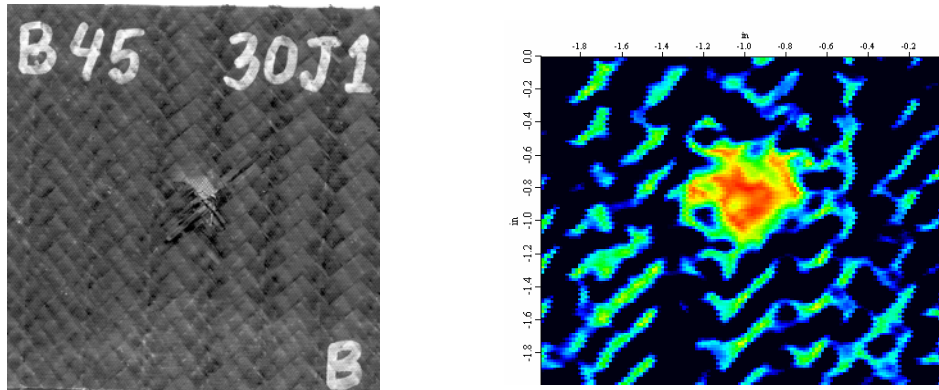
Figure 4: Images of back face (left) and Ultrasonic c-scan (right) of biaxial ($\pm 45^\circ$) braided composite laminate impacted at 30 J

From the ultrasonic c-scan studies it was seen that the laminates did not show any damage at 10 J. Some of the laminates showed damage at 20 J. Of the three samples tested only two laminates showed damage at 20 J for the $\pm 45^\circ$ and $0^\circ/\pm 45^\circ$ layups, whereas all three samples of $0^\circ/\pm 60^\circ$ layups showed damage. The damage for the biaxial layup laminates was 5.81 and 11.61 mm². For the $0^\circ/\pm 45^\circ$ layups, the damage was 9.16 and 6.45 mm², whereas the damage for the $0^\circ/\pm 60^\circ$ laminates was 6.45, 9.68 and 32.36 mm². The variation in the damage size is attributed to the quality of the laminate local to the point of impact. Any presence of microvoids or local misalignment of fiber tows could lead to lower local stiffness value leading to slightly higher damage. When impacted at 30 J, all three types of laminates exhibited considerable damage at the back surface. On the impact face, there was indentation damage. However, the laminates were not completely penetrated. The

three biaxial samples impacted at 30 J had 58.06, 58.06, and 64.52 mm² damage. The three $0^\circ/\pm 45^\circ$ triaxial laminates had damage of 80.65, 85.16 and 100.19 mm² whereas three $0^\circ/\pm 60^\circ$ triaxial laminates had damage of 51.61, 51.61, and 66.65 mm². Representative images of back surface and c-scan of the three types of braided composites are shown in Fig. 5-6. The damage resulting from the impact is depicted in the middle of the images. As the damage was localized, only 50 × 50 mm area of the samples was scanned. The damage was localized due to the fact that the interlacing fiber tows do not allow the damage to propagate across the fiber tows. The damage is initiated by the tensile fracture of the off-axis fiber tows which makes the laminate locally compliant allowing increased deformation. Once the fiber tow is completely cut through, it will no longer carry any load. The load carried by that tow will be transferred to the fiber tow running in the other direction. Because of the interlacing of the fiber tows in the two directions, the damage does not propagate across the width of the laminate as in the case of unidirectional laminates, but will spread through the thickness. This will result in a much localized damage to the laminate which is good as far as the residual mechanical properties are concerned. The amount of damage is also influenced by the in-plane properties of the laminate. If the in-plane properties of a particular laminate are higher, then that will sustain less damage as compared with those laminates that have lower in-plane properties. Biaxial braids, in general have higher in-plane properties due to the fact that there are only two fiber tows involved in the weave which reduces the crimping of the fabric. On the other hand, triaxial braided fabrics due to the presence of fiber tows in three directions will have more crimp and hence lower in-plane properties. On careful observation of the back surface damages, it was seen that the $0^\circ/\pm 45^\circ$ triaxial laminates had more off-axis tows damaged than $0^\circ/\pm 60^\circ$ triaxial laminates. The damage seems to spread along the longitudinal direction,

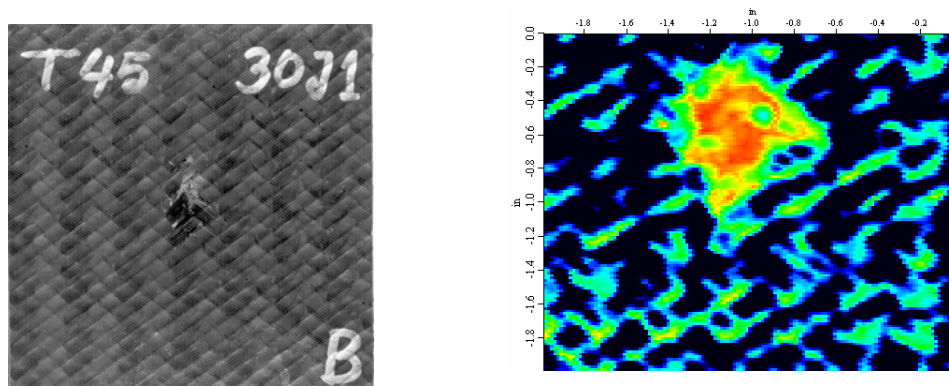
Figure 5: Images of back face (top) and ultrasonic c-scan (bottom) of triaxial ($0^\circ/\pm 45^\circ$) braided composite laminate impacted at 30 J

once the off axis tows were fractured. The shape of damage in case of the $0^\circ/\pm 45^\circ$ triaxial laminates was elliptical with the major axis along the longitudinal direction. On the other hand for the other two laminates, the damage was circular. It is also possible that the additional load carried by the $0^\circ/\pm 45^\circ$ triaxial laminates induced increased damage.

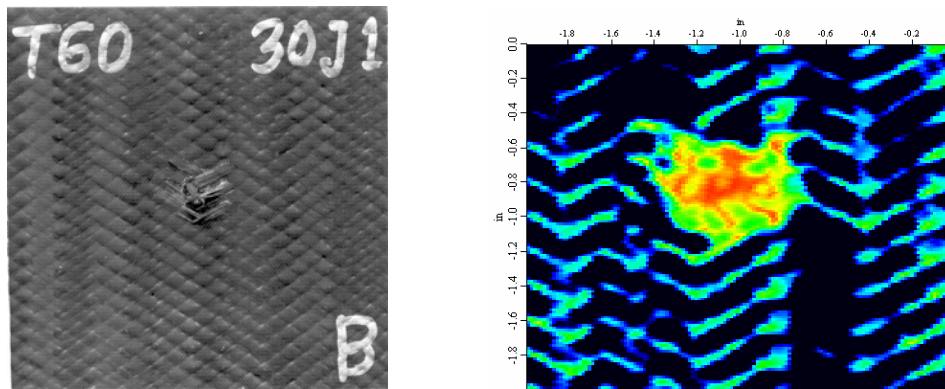
Figure 6: Images of the back face (left) and ultrasonic c-scan (right) of triaxial ($0^\circ/\pm 60^\circ$) braided composite laminate impacted at 30 J
