Study of Axial Vibration of a Motor-Compressor System Using Operational Modal Analysis

M. Farid Yahya¹, Reduan Mat Dan^{2,3,*}, M. Fadzlee Samsubaha¹, Zaini Rashid¹ and Azma Putra^{2,3,*}

¹Engineering Department, Malaysia Refining Company (Petronas), Pesiaran Penapisan, Sungai Udang, Melaka, 76300, Malaysia

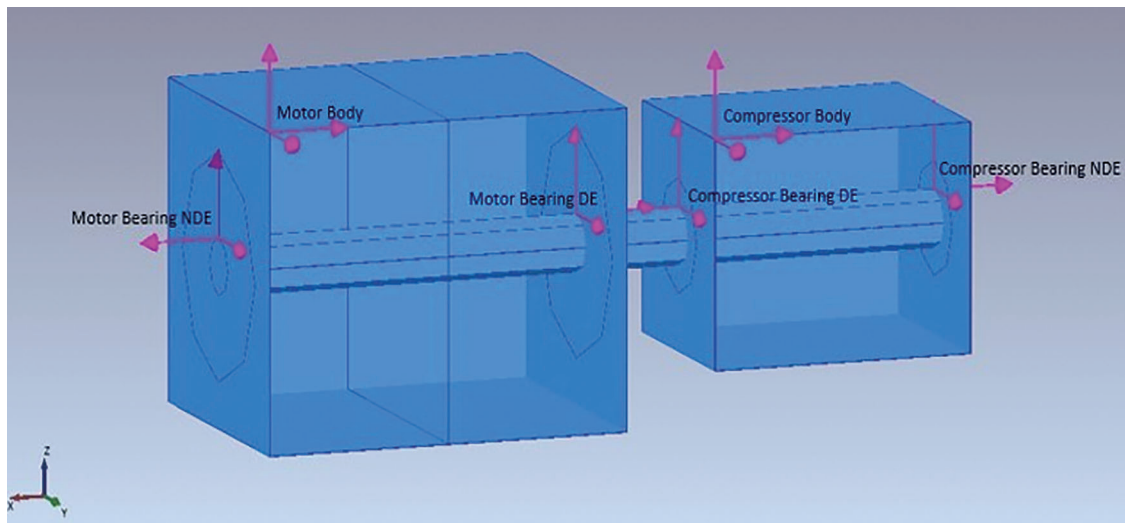
Figure 1: Diagram of the motor-compressor system

Two types of accelerometers were utilized for the purpose of monitoring vibration signals: single-direction accelerometers and radial-direction accelerometers. Single-axis accelerometers were employed to measure various locations on motor and compressor housings, whereas radial accelerometers were utilized to monitor vibration on bearing casings. Following the commissioning of the motor, the rotating machinery team conducted several sets of vibration measurements to record the overall vibration (expressed as velocity root mean square) at the usual operating speed, while the machinery was subjected to process loads. Vibration measurements were conducted at the non-drive end (NDE) and drive end (DE) positions of the shaft for each motor and compressor. The single direction accelerometers were positioned at certain places in the horizontal, vertical, and axial directions, as depicted in Fig. 1.

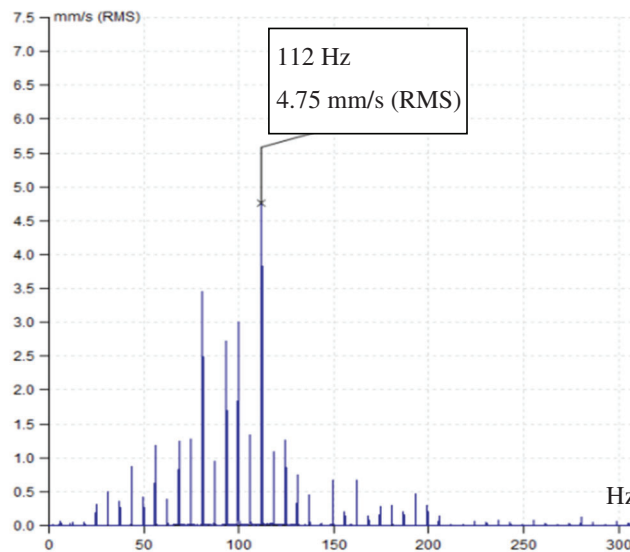
Figure 2a: Velocity spectrum at the motor in axial direction at NDE

Figs. 2a and 2b show the measured velocity spectrum from another set of recorded data, which features harmonics of the turning shaft due to the pulsation produced by the piston movement from the compressor. It can also be seen that distinct high amplitude (especially at DE, Fig. 2b) is recorded at frequency 112 Hz, which is 18 times the speed of the turning shaft (18X component). It is therefore of interest to investigate what possibly caused the vibration at this specific frequency. The Operational Modal Analysis (OMA) was conducted to observe the vibration behavior of the motor.

The measured frequency of 112 Hz in the OMA measurement aligns with the natural frequency of the system. This indicates that the observed vibration in Figs. 2a and 2b was mostly caused by resonance, namely the occurrence of the 18X component coinciding with the structural natural frequency of 112 Hz.

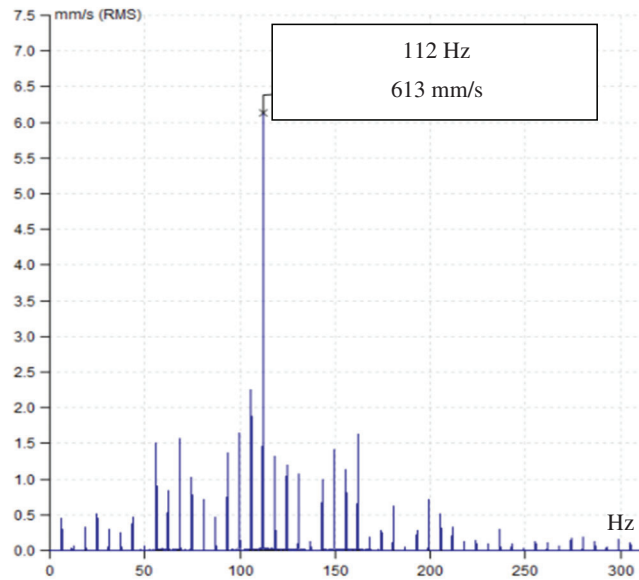
Figure 2b: Velocity spectrum at the motor in axial direction at DE

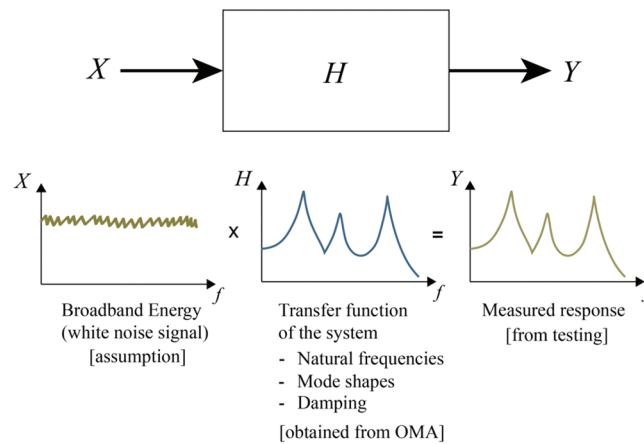
Figure 3: Illustrative diagram of the OMA method

Operating Modal Analysis (OMA) is a technique utilized to ascertain the modal characteristics of a structure based on the vibration data collected during the structure's operating state. In contrast to standard Experimental Modal Analysis (EMA), the proposed method does not necessitate the application of an external force. EMA typically involves subjecting the structure to a stationary state, disconnected from its operational state, and inducing force excitation by means such as an impact hammer or electromagnetic shaker [12].

Consequently, the OMA possesses a distinct advantage in scenarios where artificially inducing vibrations in a mechanical structure proves challenging due to factors such as its dimensions, placement, or geographical setting. Nevertheless, due to the absence of input force data in the OMA, the method must operate under the premise that the input excitation possesses broadband energy, specifically in the form of a white noise signal. The diagram depicted in Fig. 3 is used for illustrative purposes. The approach yields modal features such as natural frequencies, mode shapes, and damping.

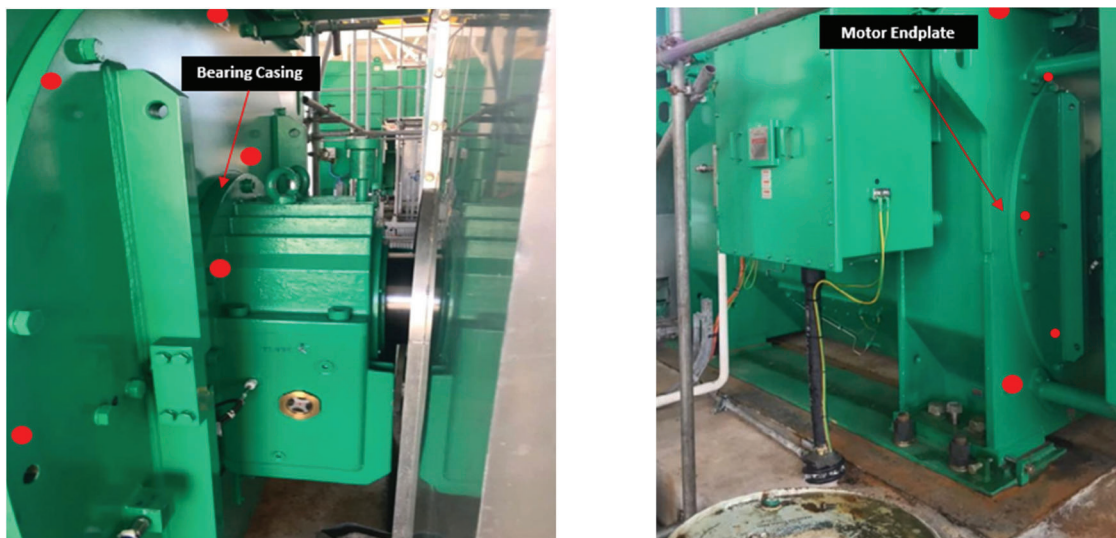
Figure 4: Location of the measurement points

Fig. 4 shows some locations of the accelerometers for OMA measurement. The measurement was divided into three sets:

- a. The initial measurement set (Set-1) contained a total of eighteen (18) accelerometers strategically positioned throughout the motor and compressor of the machine. The location of the measurement point is depicted in Fig. 4. The measurement is conducted concurrently in order to acquire the data necessary for visualizing the relative motion between the motor and the compressor. The data acquired at each point encompassed measurements of vibration in the horizontal (Y-axis), vertical (Z-axis), and axial (X-axis) axes.

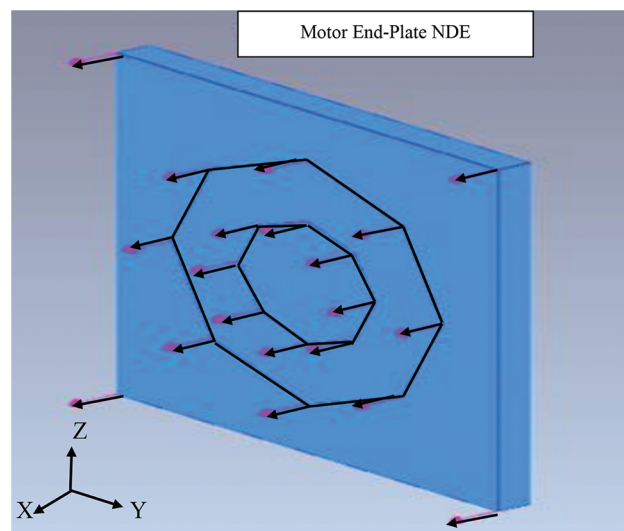
Figure 6: Diagram of the motor endplate. The arrow shows the location and measurement directions of the accelerometer

- c. The third measurement set (Set-3) was conducted at the motor end-plate, both at the drive end (DE) and non-drive end (NDE). Twenty (20) accelerometers were utilized throughout each DE or NDE. The recording of just axial directions was conducted with the purpose of observing the bulging impact on the endplate. The diagram is depicted in Fig. 6.

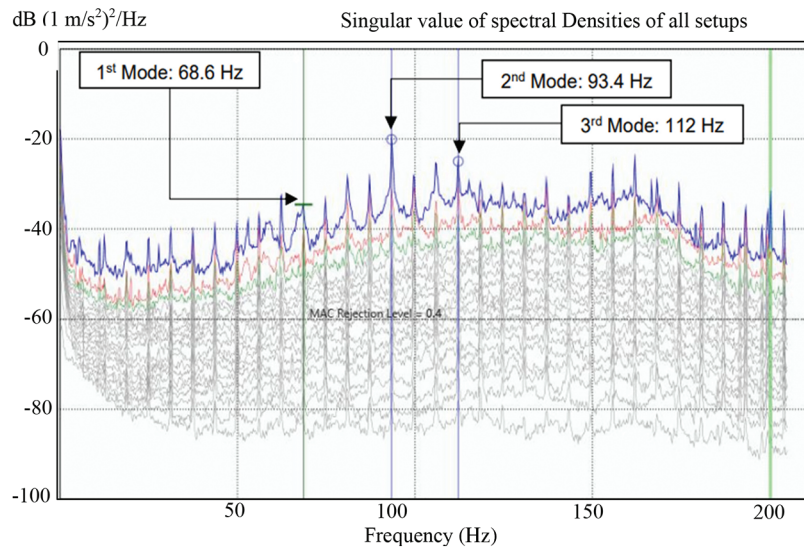
Figure 7: SVD plot from the Set-1 measurement (body of motor-compressor)

Fig. 7 displays the plot of the Singular Value Decomposition (SVD) derived from the post-processing of Operational Modal Analysis (OMA) conducted on the motor-compressor body. Three significant modes were obtained by the use of automatic mode estimate in the OMA post-processing software.

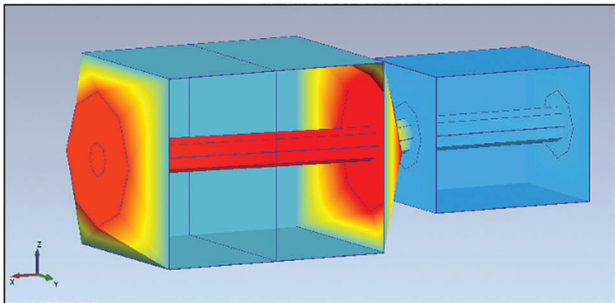
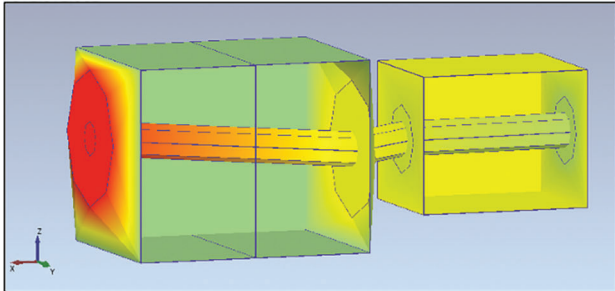
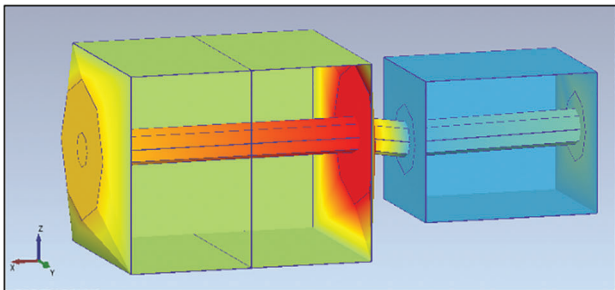
The three natural frequencies that have been emphasized are 68.6, 93.4, and 112.2 Hz. Fig. 8 displays the mode shape corresponding to each frequency. At a frequency of 68.6 Hz, it was noticed that the endplate of the motor exhibited the greatest deflection in the axial direction, with both ends bulging outward along the x-axis. At a frequency of 93.4 Hz, it was observed that both the motor and the compressor exhibited an out-of-phase movement. At a frequency of 112.2 Hz, the motor exhibited a phenomenon commonly referred to as “wobbling,” which suggests that the motor’s shaft underwent torsional motion, deviating off its rotational centreline.

Figure 8: The mode shape of the motor-compressor system at particular natural frequency

The reciprocating compressor's pulsation generally generates a vibration spectrum with harmonic patterns at various running speeds, which can then be transmitted to the driven equipment, such as the motor. The torsional vibration in the reciprocal compressor-motor system was caused by harmonic excitations. Resonance is observed when the stimulation frequency of a vibrating system aligns with its natural frequency. The investigation revealed, through the conducted Operational Modal Analysis (OMA), that one of the observed torsional natural frequencies corresponded closely to the 18 times running pace, with a value of 112 Hz. Resonance, as a phenomenon, has the potential to be amplified in all directions, however its impact is particularly pronounced on the weakest point or structure. Therefore, it is necessary to elucidate the reasons behind the phenomenon of increased amplification of axial direction vibrations when the running pace reaches 18 times the normal speed.

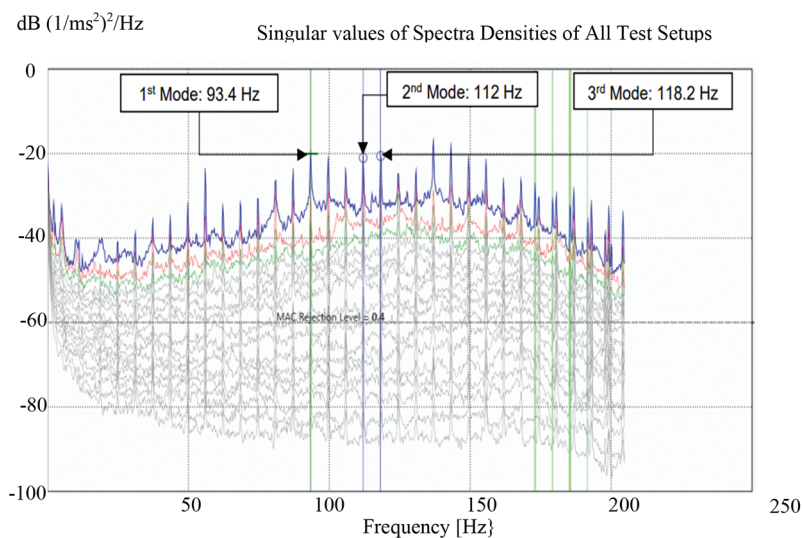
Figure 9: SVD plot from the Set-2 measurement (bearing casings)

Fig. 9 shows the SVD (Singular Value Decomposition) plot from the Set-2 measurement (around the bearing casings). Here, 112 Hz again appear as one of the highlighted mode shapes. The torsional motion can be observed from the mode shape simulation shown in Fig. 10, which supported the finding of rotational motion in Fig. 8.

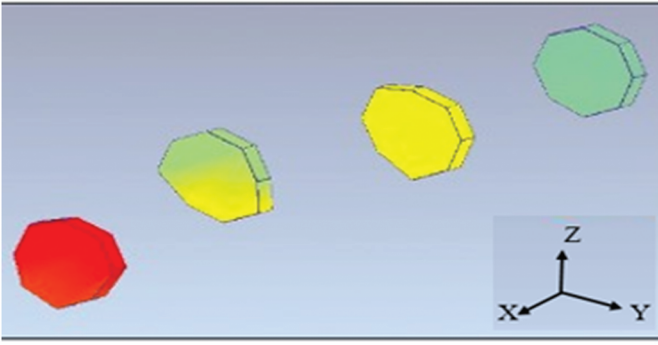
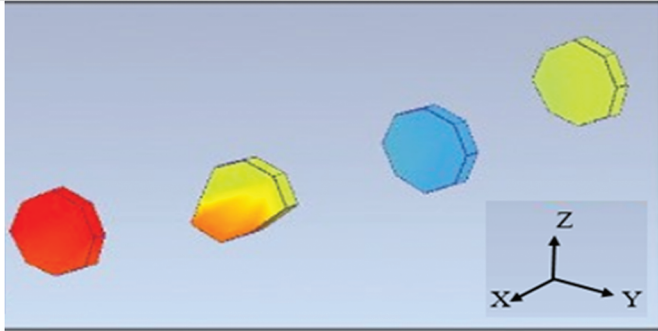
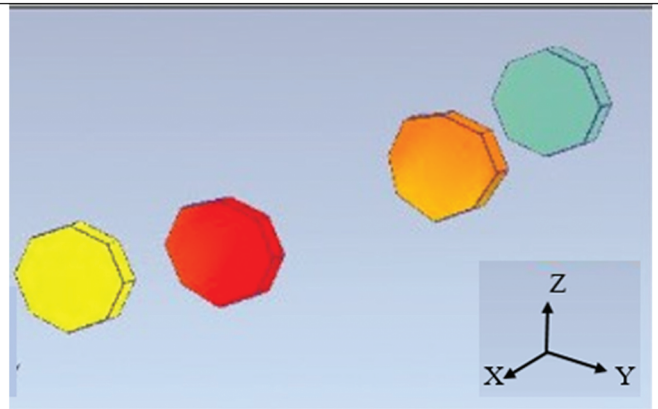
Figure 10: The mode shape of the bearing casing at particular natural frequency

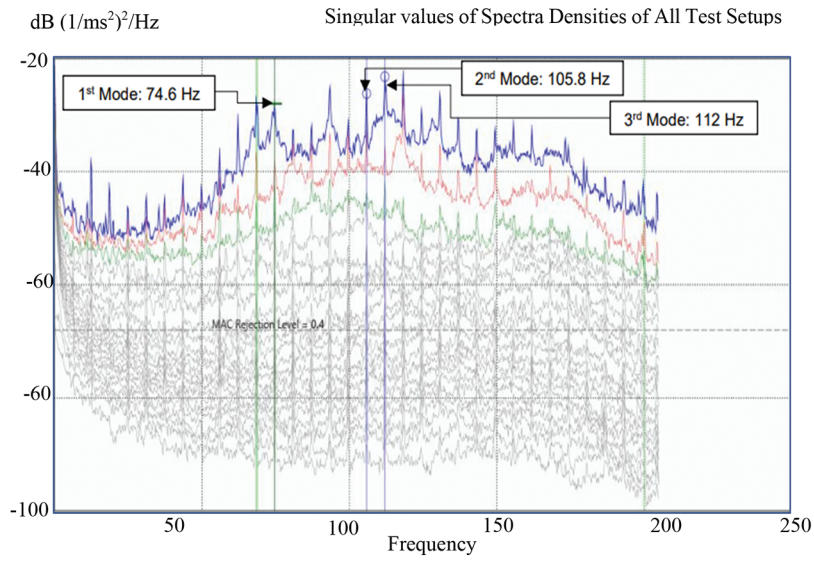
Figure 11: SVD plot from Set-3 measurement (endplate-NDE)

Fig. 11 shows the SVD (Singular Value Decomposition) plot from the Set-3 measurement (endplate). Again here, 112 Hz is highlighted as one of the natural frequencies.
