ARTICLE

Analysis of the Microstructure of a Failed Cement Sheath Subjected to Complex Temperature and Pressure Conditions

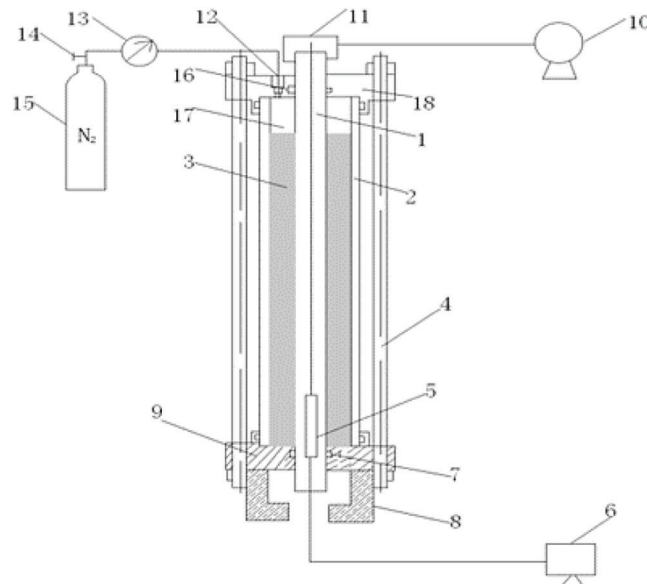
Figure 1: Schematic diagram of small-size evaluation device for cement sheath sealing integrity (1-inner casing; 2-outer casing; 3-cement sheath; 4-high strength tie rod; 5-heating rod; 6-temperature control system; 7-sealing ring; 8-foundation; 9-lower flange; 10-booster pump; 11-upper inlet hole; 12-air inlet; 13-pressure gauge; 14-pressure relief valve; 15-nitrogen cylinder); 16-sealing ring; 17-the oil layer above the cement slurry (Pressurized to prevent boiling of high temperature cement paste); 18-upper flange

To simulate the high-temperature and high-pressure conditions in realistic working, a small-size casing-cement sheath-casing combination evaluation device is designed, as illustrated in Fig. 1. According to the similarity principle, the inner casing diameter of the evaluation device is 35 mm, the wall thickness is 6 mm, the outer casing diameter is 50 mm, and the wall thickness is 3 mm. The plugs seal the upper and lower ends of the combination are sealed using the plugs and set with a pressure differential between 0.01 MPa and 0.05 MPa. High temperature can damage cement sheath, resulting in gas channeling, and that gas channeling can be simulated by this device. The evaluation device for cement sheath sealing integrity can regulate internal casing temperature and pressure. The device can sustain a 0–10 MPa cement slurry annulus pressure and a 0–10 MPa annular gas channeling pressure, the casing can sustain a 0–35 MPa pressure and a 0–180°C temperature. The gas source is N_2 .

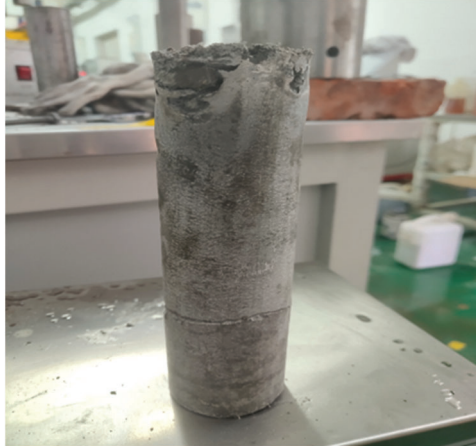
Figure 2: Experimental sample of the cement sheath

groups of cement stones are cured at 50°C, 90°C, 130°C, 150°C, and 180°C, respectively. One of the experimental cement sheath samples is shown in Fig. 2.

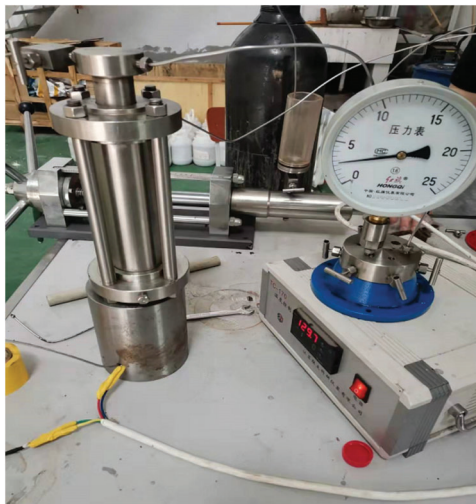
Figure 3: Evaluation device for cement sheath sealing integrity

(1) In the curing apparatus, the inner wall of the outer casing is covered with an even layer of lubricant and is affixed with a thermoplastic tube heated with hot water. The evaluation device for cement sheath sealing integrity is assembled in order, with the heating rod and temperature sensor connected to the base, as shown in Fig. 3.

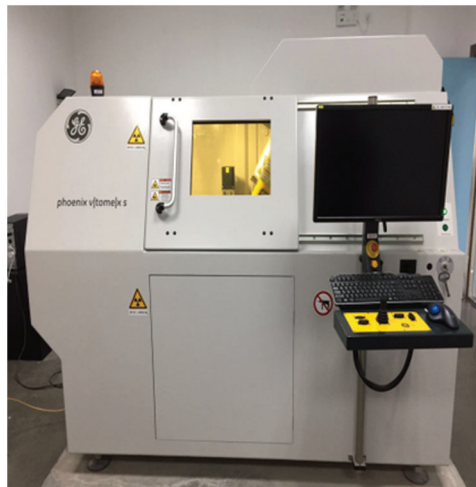
Figure 4: CT scanner

(4) The heating rod and temperature sensor is turned on, and then the cement sheath is cured at a set temperature and pressure for 7 days. After curing, the cement sheath is taken out and scanned by the CT scanner, as shown in Fig. 4.

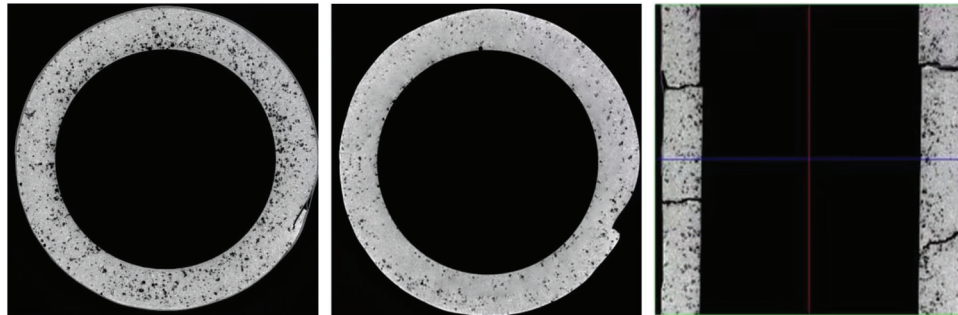
Figure 5: The microstructure change by CT scanning results with a different casing pressure

Based on the preceding experimental steps, the indoor experimental analysis of the microstructure change of cementing cement sheath under different temperatures and pressures is accomplished. Using the cement sheath cured in high-temperature and high-pressure conditions, a microstructure experimental test can be carried out, and the casing pressure is raised by 10 MPa, 20 MPa, and 30 MPa, respectively. The CT scanning results are shown in Fig. 5.

The black dots in the figures represent the pores identified by CT microscopic scanning. The detection results reveal that the pore distribution is uniform when cement sheath is cured at high temperatures and high pressures. When casing pressure rises to 10 MPa, the pore near the inner casing wall becomes dense, causing internal micro-cracks of the cement sheath. When casing pressure rises to 30 MPa, the internal structure of the cement sheath is damaged, resulting in the sealing failure of the cement sheath.

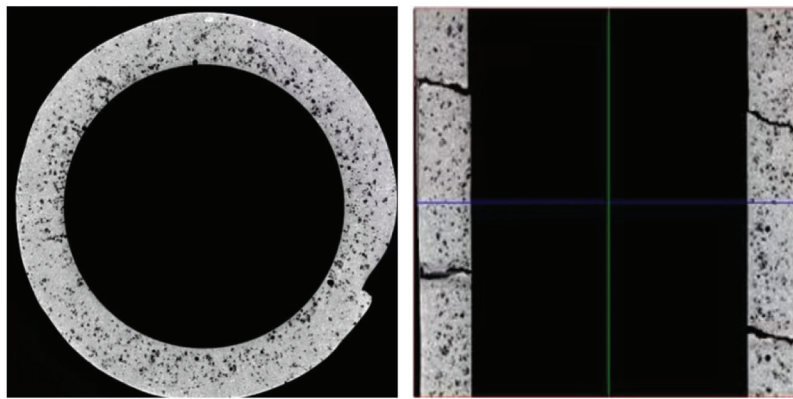
Figure 6: The microstructure change by CT scanning results with different casing temperature

Fig. 6 shows the CT detection results after changing the temperature in the casing is changed by 20°C, 40°C, and 60°C, respectively, which reveal that increasing the temperature in the casing has little effect on the pore structure, and the pores are evenly distributed across the cement sheath. When the temperature rises to a certain degree, micro-cracks appear inside the cement sheath.

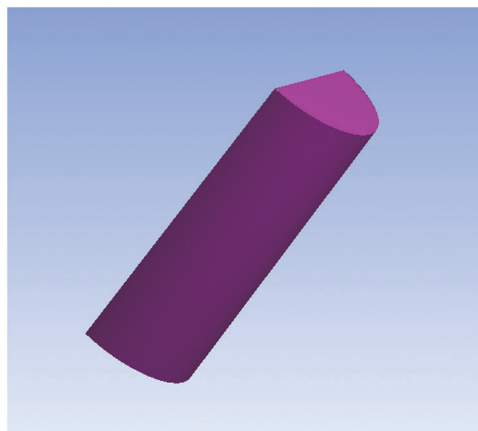
Figure 7: Half of the three-dimensional geometrical model of the cement sheath sample

Fig. 7 shows the three-dimensional geometrical model of the cement sheath sample. The model is of the same size and material as the sample in the experiment. The physical model needs to be meshed and divided into hexahedral meshes for numerical simulation, as shown in Fig. 8. The average mesh spacing is about 2.5 mm, and there are about 3000 meshes in total. Based on the numerical simulation model, temperature, pressure, as well as other experiment-relevant condition parameters are set, and the numerical simulation computation is carried out using finite element analysis software [25]. The simulation results reveal that temperature and pressure significantly impact the generation and change of the cement sheath microstructure, which is supported by the experimental results.

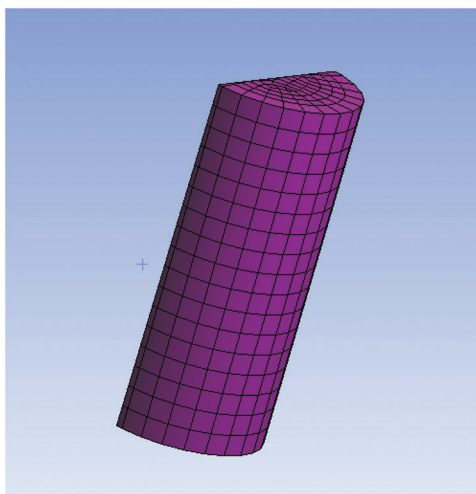
Figure 8: Mesh model of cement sheath sample
