## Improvement of UAV Based an Evaluation Approach to Mid-High Rise Buildings' Exterior Walls

**Abstract:** This research will develop a set of assessment techniques and procedures for exterior wall deterioration detection. The proposed method is mainly based on equipped with high-resolution photographic equipment for unmanned aerial vehicle (UAV). To overcome the problems of visual inspection difficulties due to different angles and height, the proposed method provides a safer and more efficient detection way to get the buildings' exterior status. After using the proposed method to analyze the images taken from UAV, the size of the damaged area can be evaluated more accurately, and the accuracy rate of visual assessment will be significantly improved. The results of the proposed method can reduce the accidents caused by the inspection process in the critical environment and the costs incurred by the temporary facilities without sacrificing the quality of the inspection results. Then, the research will implement the existing visual assessment method because of the characteristics of rapid detection, however, the assessment results will be different from different inspectors due to

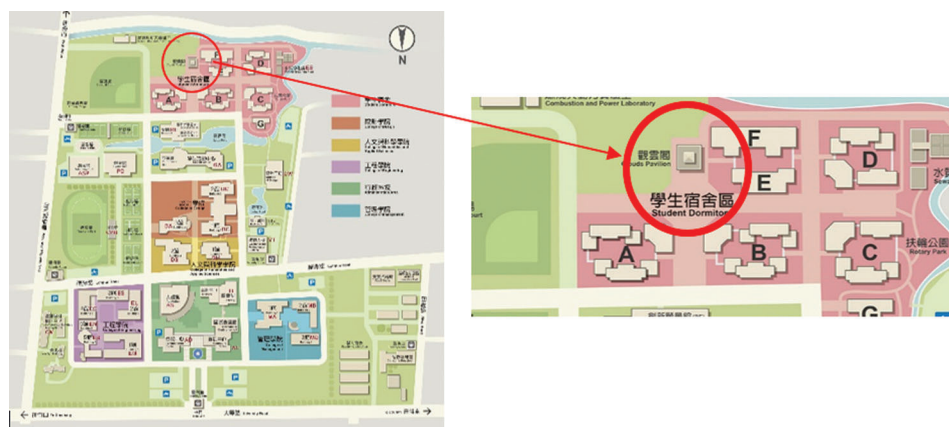
**Figure 2:** Study area (Tower Cloud Building, National Yunlin University, Taiwan)

This section describes the study area, control points, and survey parameters for research object in National Yunlin University of Science and Technology, Taiwan (Fig. 2). In this study, several constraints and factors were identified, such as: standard visual survey, according to the environments, conditions, and weather to conduct flying on January 10th, 2019.

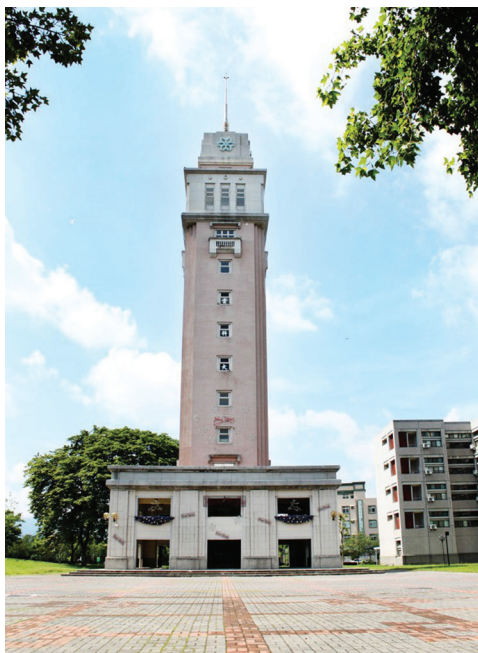
**Figure 3:** Yuntech tower cloud

Founded in 1991, Tower Cloud Building become the landmark and considered as the famous civil structure in campus area. This building has 14 floors with a facade that looks similar on each side of the exterior (Fig. 3). In some parts of this building, there are some difficult areas to conduct maintenance because the position was not accessible. Weather impact was the biggest considerable variable in implementing this research in order to promote building inspection. Visually, this building does not have many decorative structures, only standard material mainly covered with red bricks, iron, cement, and reinforced concrete.

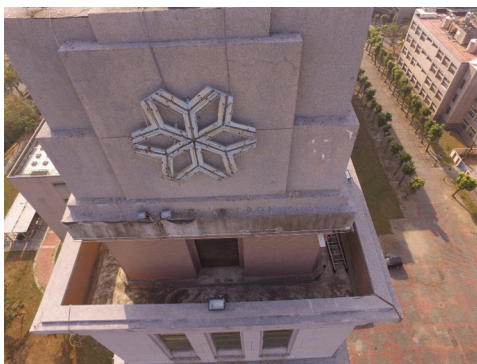
**Figure 7:** Image of overhead photography by UAV's camera

In view of the detection height for testing, currently all cases are verified at the height of over 8 floors. The fuselage remains stably controlled and the sampled images can be taken through head-up photography and overhead photography. As shown in Fig. 7, the remote and timely inspection mode added with the high-resolution image can be used to obtain and magnify images as shown in Fig. 8. In addition, by comparing the

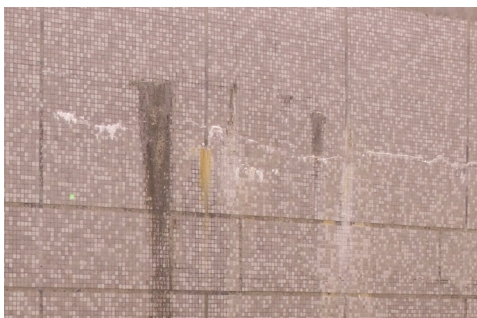
**Figure 8:** Image of close-range horizontal photography by UAV's camera

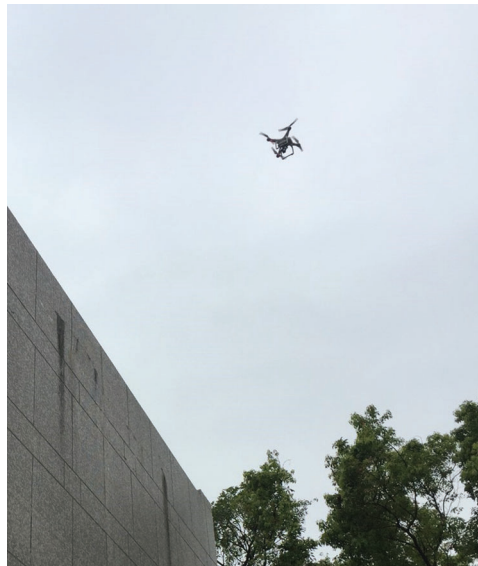
**Figure 9:** Image of ground side-shot implementation process

side-shooting and the real-time UAV inspection as shown in Fig. 9, The detection program can also use infrared thermal imager to detect the difference in the image as shown in Fig. 10, and then use UAV image to increase the accuracy of detection position as shown in Fig. 11. By means of real case detection, images are obtained by the image transmission system and information screenshots can be made by smart phone or tablet to facilitate recording. Parameters such as height, GPS position and azimuth and real-time images are shown in Fig. 12. This study also integrates image comparison technology. By comparing 2D plane CAD image with actual detection images, annotation method in the CAD drawing system is adopted to obtain the size, which serves as a basis for estimating the size and range of damaged area and subsequently improving the accuracy and completeness of detection results as shown in Figs. 13-1 and 13-2.

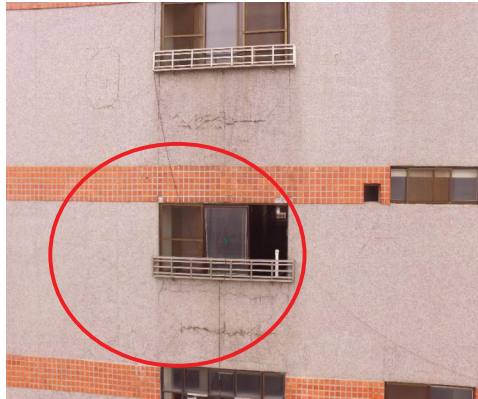
**Figure 11:** UAV-acquired Image

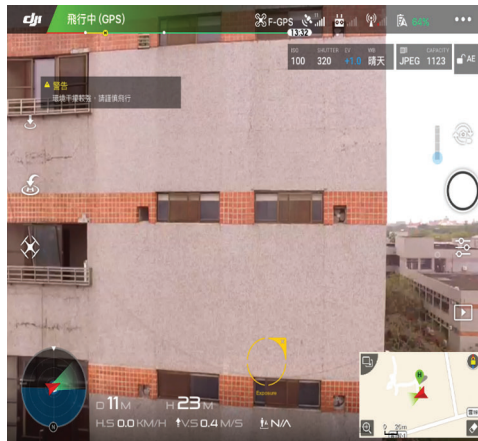
**Figure 12:** Image of obtaining information of inspection execution

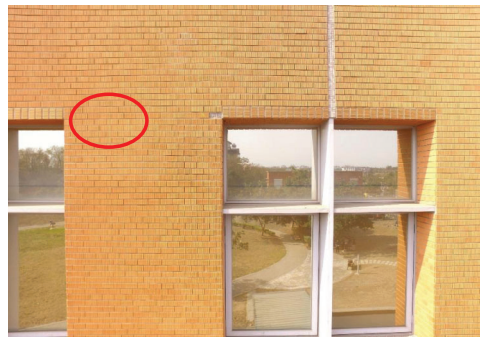
**Figure 13-2:** Actual aerial photograph of inspection
