Seismic Assessment and Rehabilitation of Historic Structures

P. Gülkan¹ and S. T. Wasti¹

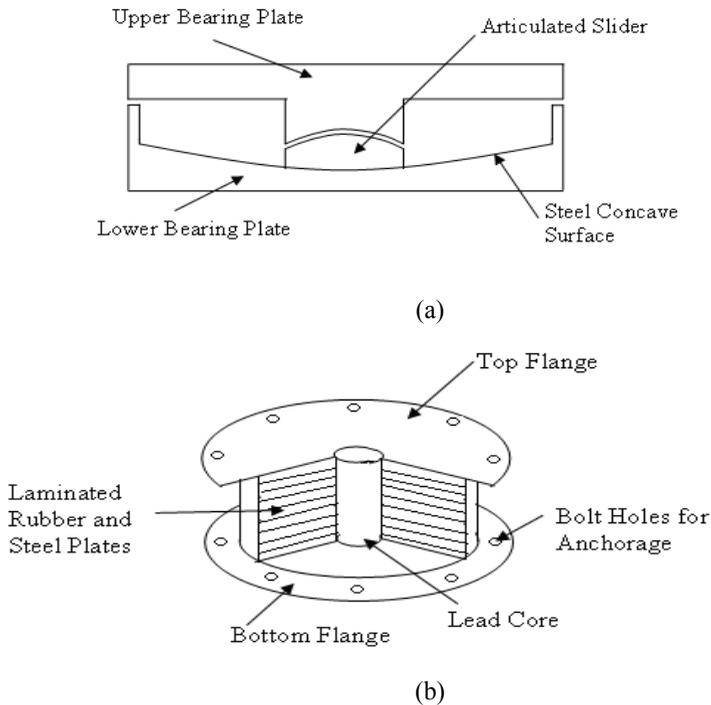
Figure 2: Friction Pendulum System [FPS] and Lead Rubber Bearing

lation elements not necessarily located between the base and the foundation of the structure. The use of friction pendulum bearings for base isolation is on the increase. Sketches of an FPS [Frictional Pendulum System] and a typical LRB [Lead Rubber Bearing] are given in Fig.2 (a) and (b) below.

A large number of historic structures have now been base-isolated using either rubber bearings [divided into laminated (LRB) or high damping (HDRB) rubber bearings] or friction pendulum systems (FPS). Examples include the City Halls of Oakland and San Francisco in California. The International Terminal at San Francisco Airport and the Los Angeles City Hall have been base-isolated with friction pendulum systems. Friction pendulum systems of various dimensions similar in type to the cross-sectional view shown in Fig. 2(a) were employed.

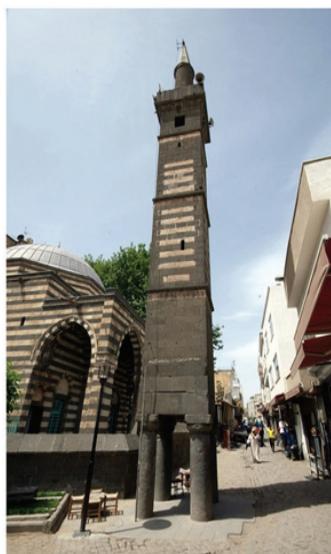
Figure 5: Free-standing Minaret

of the mosque, but is an adjacent and separate component. It is unique because the minaret body has been placed on four cylindrical stone columns (Fig. 5). There is no positive connection between the columns and the minaret. This minaret is seemingly vulnerable though it has survived for five centuries in a city that is subjected to moderately strong earthquakes. In order to investigate the likely seismic performance and strength of the four-legged minaret, the architectural renderings of the minaret have been examined.

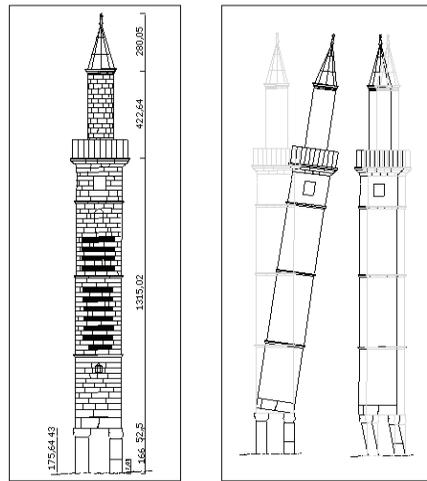
Figure 6: Geometry of the Minaret

If the minaret has been able to stand without toppling for five centuries, then it is possible to estimate which upper ground motions it must have experienced. The structure measures about 2.0 m square in plan and stands above four 1.75 m tall basalt pillars that are topped with stone lintels supporting the 13 m tall masonry body of the structure to the level of the balcony. Then there is a 4.2 m long cylindrical part followed by a 2 m tall timber cone giving it the familiar architectural profile in Fig. 6.

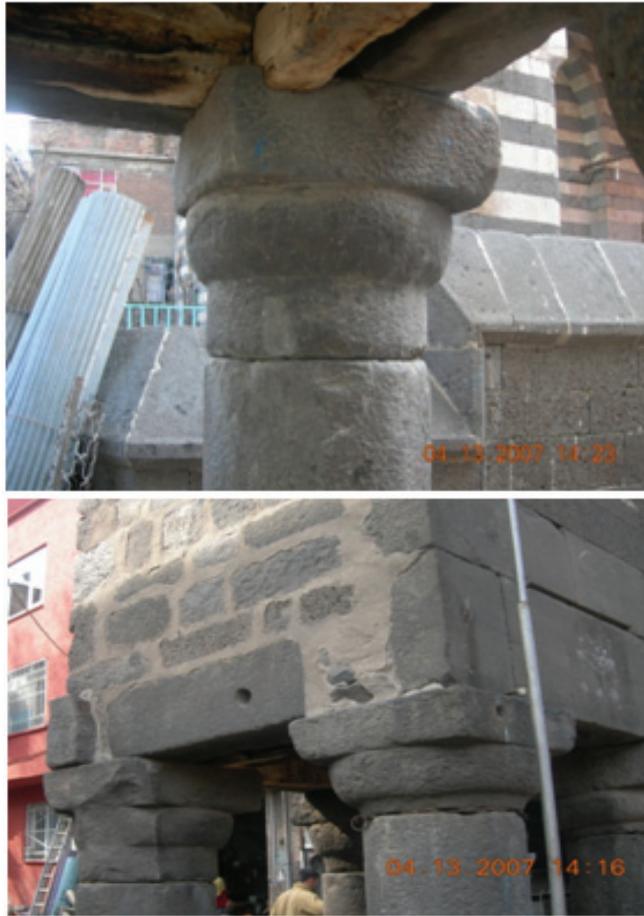
Figure 7: Support Details of the Base of the Minaret

It is observed that the approximately 22 m tall mosque appurtenance sits freely above the circular, 0.5 m diameter supporting pillars 1.75 m in height (Fig. 7). The top ends of the pillars are free for purposes of analysis, but the conditions below the grade level are not known. The two extreme possibilities are shown in the right frame of Fig.6. If the bottom ends are fixed perfectly into the foundation then the only feasible type of dynamic motion for the minaret would be to rock at the lintel

level, the situation described in the figure on the left. If the bottom ends of the pillars are similar to their upper ends then it will be the pillars that rock, allowing the rest of minaret to follow their motion as a horizontally translating mass.

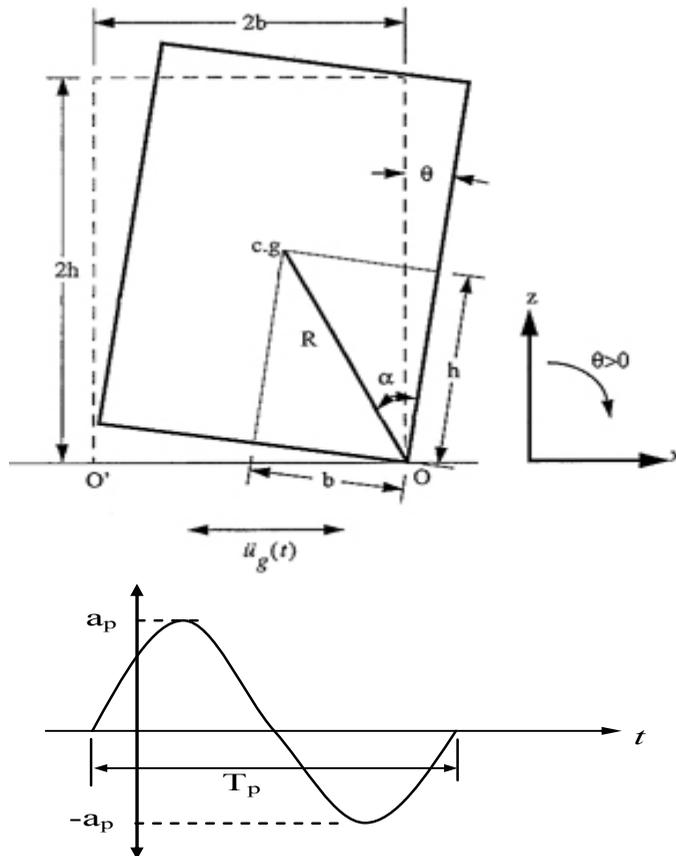
Figure 8: Dynamics of Rigid Blocks

The first eventuality is represented as the idealized rocking rigid block of Fig. 8. With sufficient friction developing across the plane of contact the block will move as shown in the sketch, rocking alternatively around its two corners O and O'. The seminal work for the analysis of such blocks has been done by Housner (1963), paving the way for later investigations, e.g., Makris and Roussos (1998) and Anooshehpour et al. (1999).

The fundamental question to be answered is: what is the ground motion pulse that will cause the block in Fig. 8 to topple? This is not a question that has a unique answer because both the amplitude a_p and duration T_p of the pulse determine that response. A series of dynamic response calculations for the minaret indicated the combined response limits illustrated in Fig. 9. Reducing the ground motion to a sinusoidal pulse is a necessary simplification for purposes of the current analysis, but the region to the left and lower side of the curve is the safe region for the minaret. It is seen that long period pulses are more dangerous for the geometry of the structure here.

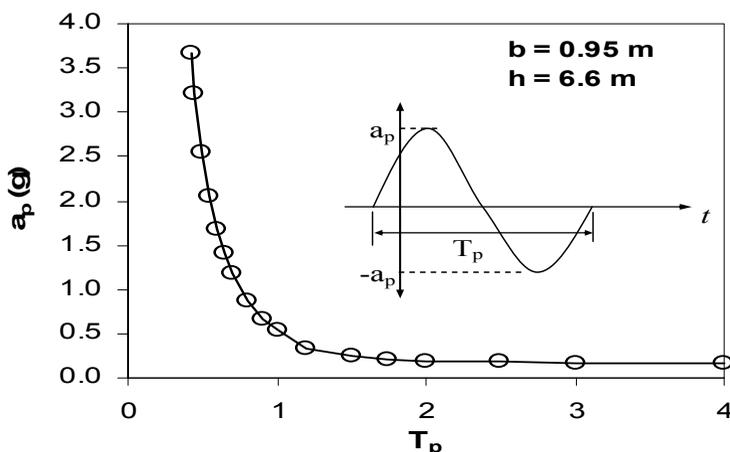
Figure 9: Safe and Unsafe Regions for a 13.2 m tall, 1.90 m Wide Block

Whereas a 2-s pulse needs to have a 0.15 g peak, a 1-s pulse must be above 0.5 g and a 0.7-s pulse needs to be above 1 g in amplitude to cause a catastrophic amount of rocking. As the duration of the pulse becomes longer the estimate of the amplitude that leads to toppling approaches the static acceleration of about 0.11

g. The curve is only an approximate estimate of the ground motions that occurred in Diyarbakir during the last half-millennium. The alternative idealization for the fixity of the supporting pillars in Fig. 8 leads to the estimate that the peak ground velocity during the same period cannot have exceeded 0.8 m/s.
