**ARTICLE****Initiation Mechanism of Transverse Cracks in Wind Turbine Blade Trailing Edge**Jinghua Wang¹, Leian Zhang¹, Xuemei Huang^{1,*}, Jinfeng Zhang² and Chengwei Yuan¹¹School of Mechanical Engineering, Shandong University of Technology, Zibo, 255049, China²China General Certification Center, Beijing, 100013, China

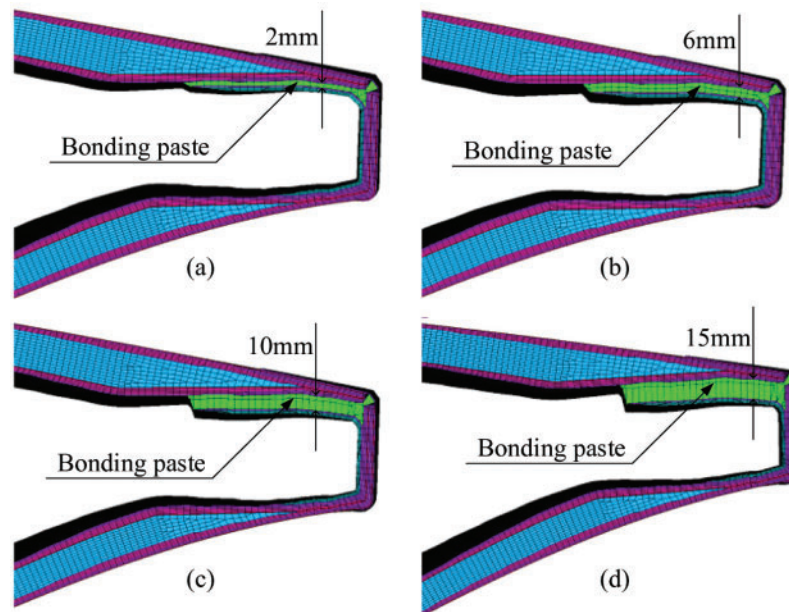
Figure 5: Solid element model with different bonding paste thickness (a) With thickness 2 mm, (b) With thickness 6 mm, (c) With thickness 10 mm, (d) With thickness 15 mm

K_t represents the level of stress concentration of the crack regions. It can be seen from Table 1 that the stress concentration factor K_t and λ have a noticeable increase with the adding of adhesive thickness. It indicates that the stress contribution factor of bonding paste in global structure performance increases with adhesive thickness. The bonding paste absorbs a larger fatigue load when has a thicker adhesive. Simultaneously, laminate with cracks will release more stress and transfer to the surrounding laminate so that the adhesive joint can obtain a higher stress concentration factor, which makes the shell more prone to fatigue cracks.

The FE results show that when the bonding paste thickness adds, the fracture will cause a more serious local stress concentration, which makes the trailing edge shell has a higher probability of fatigue failure and transverse cracks. And the actual production shows that when the bonding paste is too thick in production, it is easy to produce internal stress and cavity defects in the curing process, which makes the bonding paste has a poor performance and fatigue

There are two methods to avoid the transverse crack in the trailing edge: 1. Redesign the bonding paste of the trailing edge and reasonably determine the adhesive thickness in the blade production. 2. Adding GFF crack control layer in the laminate, which can reduce the stress concentration and improves the fatigue strength of the trailing edge. In the latest blade design, an anti-cracking layer is added to the shell at the trailing edge. After the blade fatigue test, there is no transverse crack on the trailing edge.

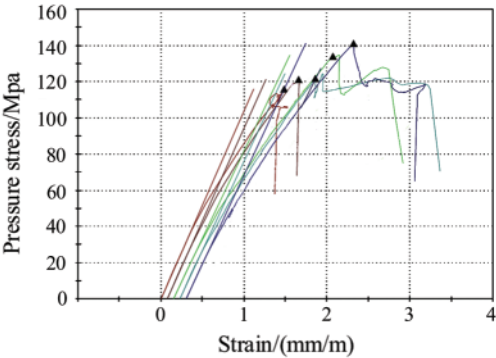
The static loading results of the sample are shown in Fig. 8. The ultimate strength values of the specimens measured by the test are 121/114/120/140/133 MPa in Fig. 9, with an average of 123.6 MPa.

Figure 9: Stress data of the specimens in static test

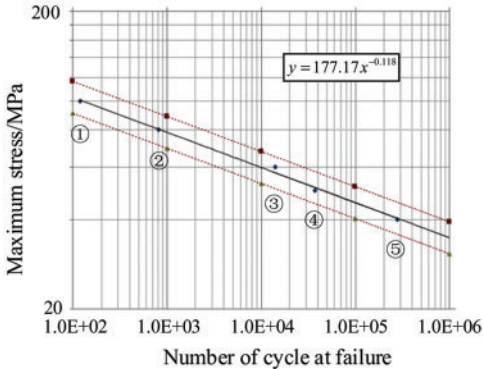
In the fatigue test, the maximum value in the load spectrum is set as 40/50/60/80/100 MPa. The cyclic load was applied to the specimens with a stress ratio of 0.05 and a frequency of 1.02 Hz until it fails, and then the S-N data of the specimens are collected. The failure modes include laminate damage and adhesive crack in Fig. 10. More serious damage was done to the specimens when subjecting to the larger cyclic load, as shown in Fig. 11. The regions marked in Fig. 10 suffered minor damage at the time of failure. The S-N curve fitted according to the test results is linear, the fitting curve can express as $y = 177.17x - 0.118$.

Figure 11: S-N data of tested specimens
