Bonded Composite Patch Geometry Effects on Fatigue Crack Growth in Thin and Thick Aluminum Panels¹

S. Mall^{2,3} and J. J. Schutte^{1,4}

Abstract: Effects of various geometric factors on the crack growth behavior of thin and thick aluminum panels repaired with asymmetric boron/epoxy bonded composite patch were investigated. Two widths, three patch lengths, three panel thicknesses and several patch-to-panel stiffness ratios were considered. Asymmetric repair introduces initial thermal curvature (or bending) in the repaired panels. The radius of curvature decreased with increase in the patch length in the thicker plates (6.350 or 4.826 mm thickness). On the contrary, the radius of curvature in the thin plate (i.e. 3.175 mm thickness) increased with increase in the patch length. The effects of stiffness ratio and patch width on the initial curvature of the asymmetrically repaired panel depended upon the length of the bonded patch, thickness of the repaired panel and stiffness ratio. There was increase in the fatigue life of the repaired panel with increase of stiffness ratio at a given patch length for all three thicknesses. For repairs of stiffness ratio equal to 1.0, the patch len

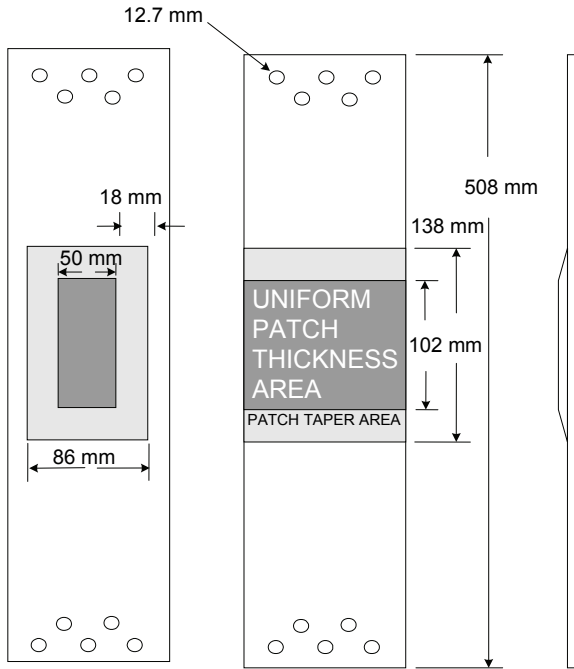
Figure 1: Repaired specimen details

The material, used in this study, was 2024-T3 sheet (unclad) aluminum. The composite patch was unidirectional boron/epoxy. Material properties, in the loading direction (fibers in composite patch were oriented in the loading direction), for the plate and patch are shown in Table 1. Specimens were configured as described in previous studies [18, 19] with a single center crack (nominal length of 25.4 mm) and rectangular patch as shown in Figure 1. Several specimens were prepared to examine a range of geometric parameters, as mentioned previously, that might influence fatigue crack growth in the repaired specimens. All patches had unidirectional lay-up, $[0]_n$ (n is the number of plies) with fibers oriented in the loading direction. Three patch lengths (102, 68 and 51 mm), two widths (full and finite), and several stiffness ratios are examined in this study. The patch to panel stiffness ratio, S , is defined as:

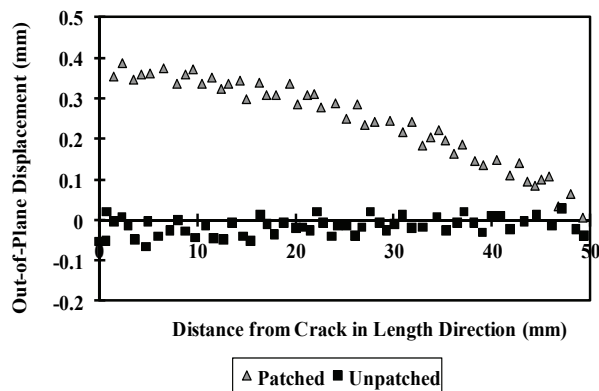
Figure 3: Out-of-plane displacement before and after patch repair

The parabolic parameters, h and k , define the coordinates of the parabola's vertex, P is the distance from the vertex to apex and the parabola's axis is the y-axis. In this study, each fit was optimized for the range of points, falling within ± 50 mm of the crack, along the centerline of the panel. Figure 3 shows an example of the curve-fit compared to the measured out-of-plane displacements. Radius of curvature, ρ , is defined as $\frac{1}{k}$, where

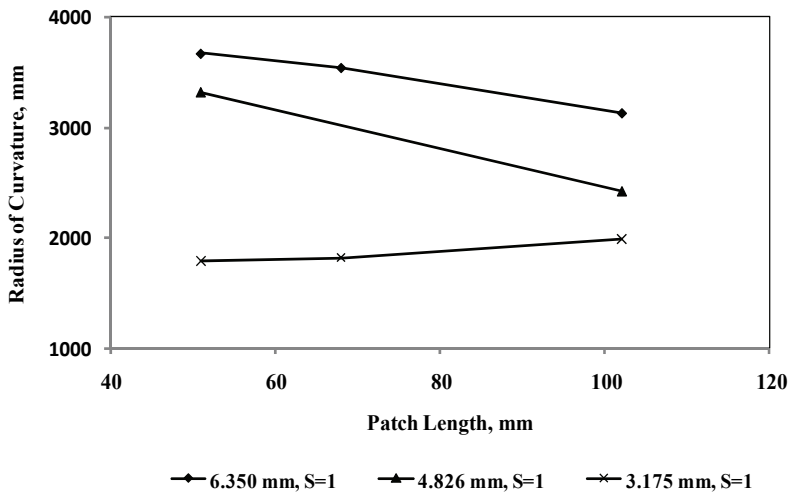
Figure 4: Effect of patch length on radius of curvature

Figure 4 shows the measured radius of curvature for three thicknesses of repaired panels with full width patch (153 mm) and for patch to panel stiffness ratio, $S=1.0$ as a function of patch length. The thinner plate had a consistently lower radius of curvature than the thicker plate for a given patch length. This dependency of the radius of curvature on the panel thickness is consistent with simple beam theory; i.e. increased plate thickness results in increased radius of curvature. However,

the initial thermal curvature did not show a consistent trend with the variation of patch length. In the thicker plates, the radius of curvature decreased with increase in the patch length and it is consistent with beam theory as well as with Rose's analysis [20]. On the contrary, the radius of curvature in the thin plate (i.e. 3.175 mm thickness) does not coincide with the expected trend from the beam theory and Rose's analysis. Therefore, prediction of thermal induced curvature effects need more sophisticated analysis than simple beam theory or simple analysis. Further, this dependence of curvature on the patch length and other parameters would have a significant effect on stress intensity factor and hence on the crack growth rate behavior in repaired panels. The latter is investigated experimentally in the study.

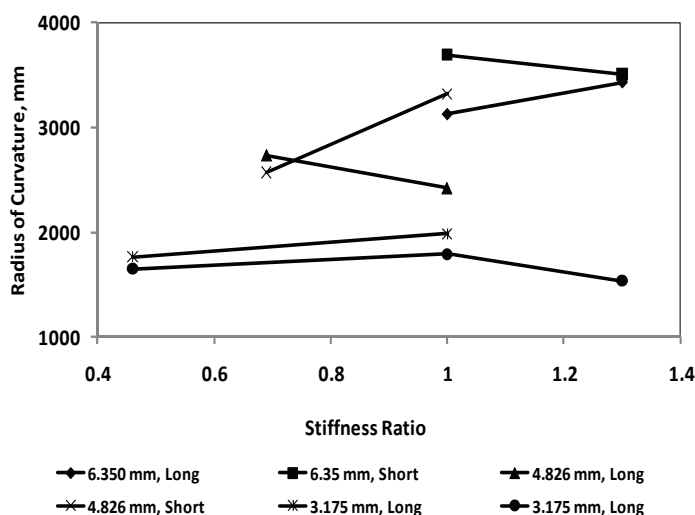
Figure 5: Effect of stiffness ratio on radius of curvature

Besides the plate thickness and patch length, the stiffness ratio would also have effects on the initial curvature from the curing of bonded patch. Figure 5 shows radius of curvature as a function of stiffness ratio for two patch lengths. Two patch lengths were: long one having 102 mm length and short one having 51 mm length. Stiffness ratio (S) change from 1.0 to 1.3 for the 6.350 mm plate with the long patch (102 mm length) increased radius of curvature by about 10% than that of the $S=1.0$ repair. Similar comparison for the short patch repair (51 mm length) for the same stiffness change showed about 5% decrease in radius of curvature. Examining the results of 3.175 mm plate with $S = 0.46, 1.0,$ and 1.3 for the short (51 mm) repair, it can be seen that $S = 0.46$ had about 8% smaller radius of curvature than the $S = 1.0$

repair. The $S = 1.3$ repair also had a smaller radius, about 14% less than the $S = 1.0$ repair. On the other hand, the long patch (102 mm) repair on the 3.175 mm panels resulted in an 11% smaller radius for the $S=0.46$ specimen over that of the $S=1.0$ specimen. The 4.826 mm panels were also examined with $S = 0.69$ and $S = 1.0$. Measurements showed that the $S = 0.69$ repair with the short patch (51 mm length) resulted in about 22% smaller radius of curvature than the $S = 1.0$ while the $S = 0.69$ repair on the 4.826 mm plate with long patch showed about 13% larger radius than the $S = 1.0$ specimen. These data, even though limited, clearly suggests that the effect of stiffness ratio on the initial curvature of the asymmetric repair would depend upon the length of the bonded patch and thickness of the repaired panel, and there is no simple trend among these parameters.

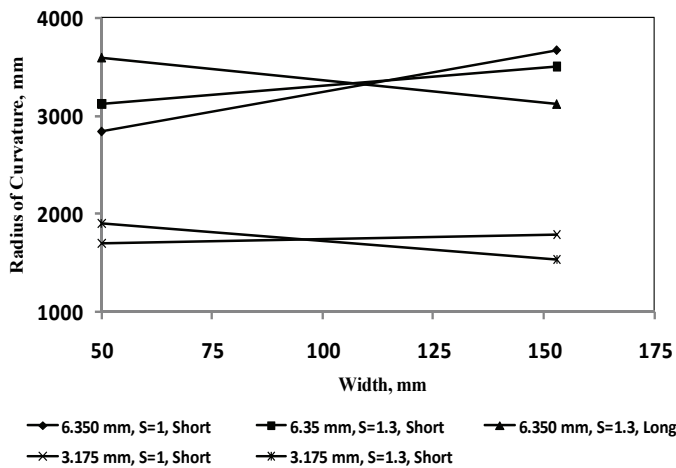
Figure 6: Effect of width on radius of curvature

The effect of the patch width on the initial curvature is shown in Figure 6. Examination of the effect of width patch on post-repair plate curvature shows two trends. First, for the long patch (102 mm) repair on the thick plate with $S = 1.3$, there was increase of about 10% in radius of curvature with a finite width patch (50 mm) relative to the full width patch (153 mm). Second, for the same thickness but with a short patch (51 mm), there was about 10 ~ 15% decrease in radius of curvature with a finite width relative to the full width for both stiffness ratios of 1.0 and 1.3. The change in the radius of curvature of repaired thin plate (3.175 mm) with short patch and $S = 1.0$ follows the same trend as the thick panel. On the other hand, the higher stiffness (1.3), short and finite width patch on the thin plate (3.175

mm) resulted in about 20% increase in radius of curvature relative to the full width. These data, even though limited, again suggest that the effect of the patch width on the initial curvature of the asymmetric repair would depend upon the length of the bonded patch, thickness of the repaired panel and stiffness ratio.

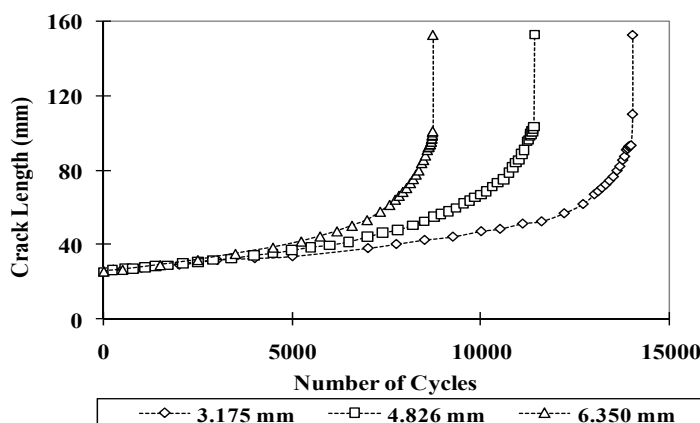
Figure 7: Crack length versus cycle relationship for unrepaired panels

Figure 7 shows the crack length versus fatigue cycle relationships of unrepaired panels for three thicknesses: 6.35, 4.826 and 3.175 mm. Fatigue life decreased with increase of thickness. This dependence of fatigue life on the thickness was also observed by Broek and Schijve [21]. Fatigue life of unrepaired thin panel (3.175 mm) was about 1.6 times longer than that of the unrepaired thick panel (6.35 mm) as seen in Figure 7. The repaired thin panels also showed considerable improvement after repair, i.e. longer life (in the range of 2 ~ 3) relative to the repaired thick panels with similar patch configuration (i.e. same stiffness ratio, length and width) as discussed in the following. Thin panel versus thick panel repairs display different response to repair and crack growth mechanisms. Therefore, a thorough understanding of the fatigue behavior of the repaired panels is needed in order to further improve their fatigue lives. This study is a step in this direction.

Examination of debond growth in all specimens tested in this study showed a similar growth pattern of debond (i.e. size and shape), regardless of patch length and width as well as stiffness ratio. Significant debond growth (away from the immediate area of the crack) occurred only either when change in patch thickness occurred (i.e. in its taper portion), or when the crack reached a length where it would have grown unstable in the unrepaired specimen. The unrepaired specimens failed catastrophically at crack length of approximately 90 ~ 100 mm during cycling as can be

seen in Figure 7. This means that at this crack length, the maximum applied load of 120 MPa on the repaired specimen created a condition where the stress intensity factor from the fatigue load at the crack tips exceeded the critical stress intensity factor, K_C of the unrepaired panel. This stress intensity factor caused the crack to grow unstably momentarily in the repaired panel. Similar condition also developed when there was a change in the patch width. This resulted in local plastic yielding, and consequently crack growth retardation similar to change in growth rate observed when a component experiences a stress overload. This behavior is shown in Figure 19. As can be seen in this figure, a momentary reduction in the crack growth rate occurred near crack length equal to 100 mm for the full width patch or near crack lengths equal to 50, 86 and 100 mm in the finite width patch, i.e. where its thickness changes. Thus once debond occurred, crack growth rates became erratic. Thereafter, crack growth rates were not only affected by the patch parameters but also on the amount and rate of debond, and thereafter the crack growth behavior became very complex. Hence, the characterization based on total fatigue life does not characterize accurately the effects of the patch parameters. So, present observations on the patch geometry effects, until debond growth occurred, have usefulness in the design of patch repair.

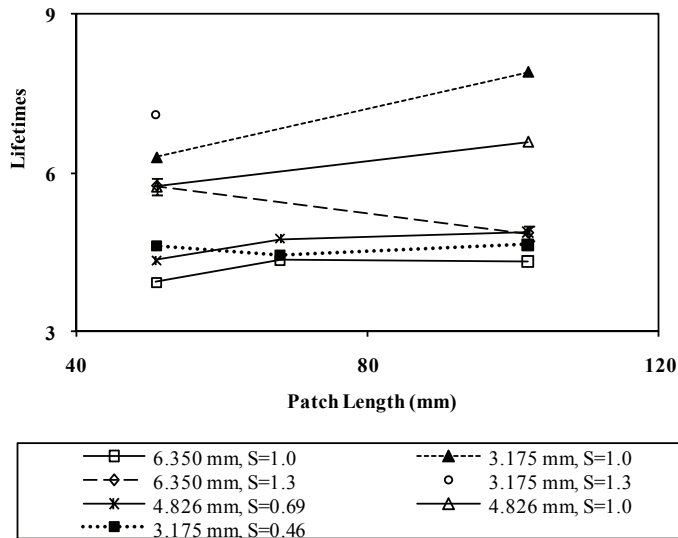
Figure 8: Effect of patch length on fatigue lifetime

Figure 8 shows the combined effects of stiffness ratio and patch length on the life improvement which is the ratio of repaired panel’s total life to the corresponding unrepaired panel’s total life for all three thicknesses. This is for the full width patch (153 mm). It is interesting to note that there is increase in the life improvement with increase of stiffness ratio at a given patch length for all three thicknesses. For repairs of stiffness ratio equal to 1.0, the patch length had practically no or small effect on fatigue life of the repaired thick panels, but increase in patch length improved the fatigue life of the repaired thin panel. But, with stiffness ratio of 1.3, the longer patch length on the thick panels decreased the fatigue life in comparison to the shorter patch. Therefore, there is practically no benefit or even a possible detrimental effect of the increased patch length on the fatigue life during the repair of thick plates. Thus, the current guidelines for the thin panel repairs that recommend the use of a longer patch are not directly applicable to the thick panel repairs. Therefore, the effects of stiffness ratio and patch length on the fatigue life improvement of the repaired panel are complex which require more studies. However, asymmetric repair of cracked panels with bonded composite patch increased their fatigue lives by at least four times relative to the unrepaired panels and in some cases even much more.

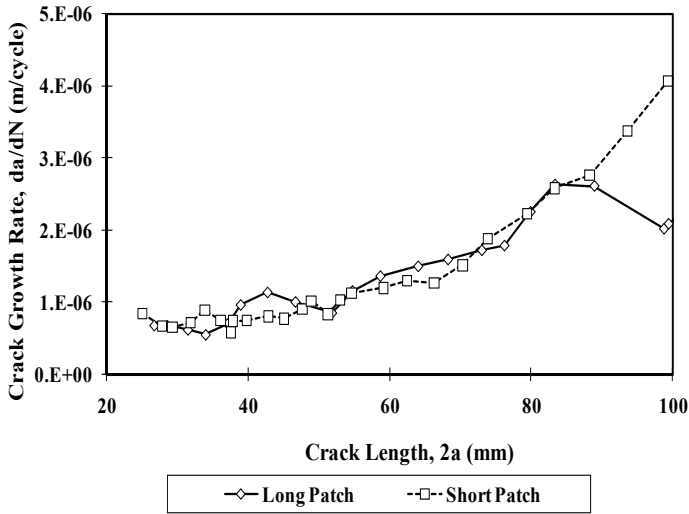
Figure 9: Crack growth rate versus crack length, 6.350 mm, S = 1, long versus short patch

Bending, caused by the shift of neutral axis, in asymmetric repair decreases with the increase of the patch length. Therefore, the bonded repair guidelines recommend the use of longer patch length. However, these guidelines were primarily based from experiences with thin panel repairs where the initial curvature from bonding is minimal. Figure 9 compares the crack growth rates for the long and short repairs in thick panel of 6.350 mm with stiffness ratio of 1.0 up to crack length, $2a = 100$ mm, i.e. until any noticeably debond occurred. The increase in patch length had practically no impact on the crack growth rates in the thick panel repaired with the stiffness ratio of 1.0. This was expected since residual thermal stresses increased the bending effects and the loading reversed the bending to a certain extent with the longer patch, thus reducing these effects by offsetting each other. Similar behavior was observed in thick panel of 4.826 mm with stiffness ratio of 1.0 up to the crack

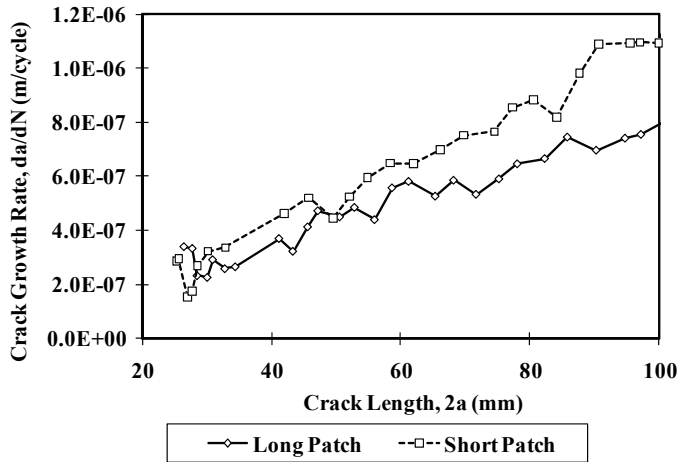
Figure 10: Crack growth rate versus crack length, 3.175 mm, S = 1, long versus short patch

length, $2a = 100$ mm, and hence these data are not shown for the sake of brevity. In other words, patch length had practically no effect on the crack growth rates before any debond occurred in the thick panels. On the other hand, the longer patch (i.e. 102 mm length) shows a definitive improvement in the crack growth rates over the shorter patch (i.e. 51 mm length) in the thin repaired panel (3.175 mm) with the stiffness ratio of 1.0 as shown in Figure 10. It should be mentioned here that there was about 20% increase in the total fatigue life in this case. However, comparison of long patch (102 mm) with short patch (51 mm) in the thick repaired panel (6.35 mm) with the stiffness ratio of 1.0 had only about 2% difference in the total fatigue life. The effect of patch length on the crack growth rate up to the crack length, $2a = 100$ mm, i.e. before any debond occurred, was almost similar with higher stiffness ratio of 1.3 in the thick plate as with stiffness ratio of 1.0 in the thin plate. Figure 11 shows this phenomenon with thick repaired panel of 6.350 mm thickness with stiffness ratio of 1.3.

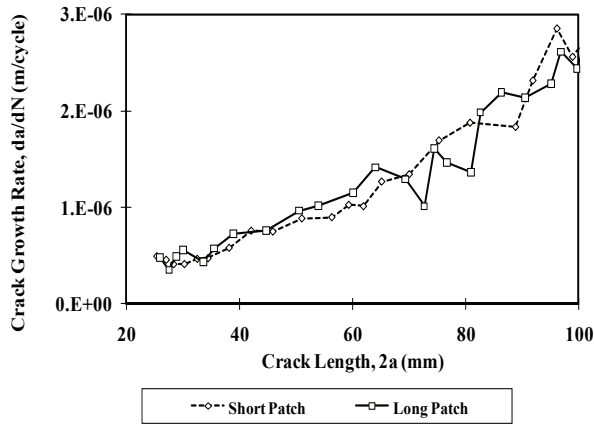
Figure 11: Crack growth rate versus crack length, 6.350 mm, $S = 1.3$, long versus short patch

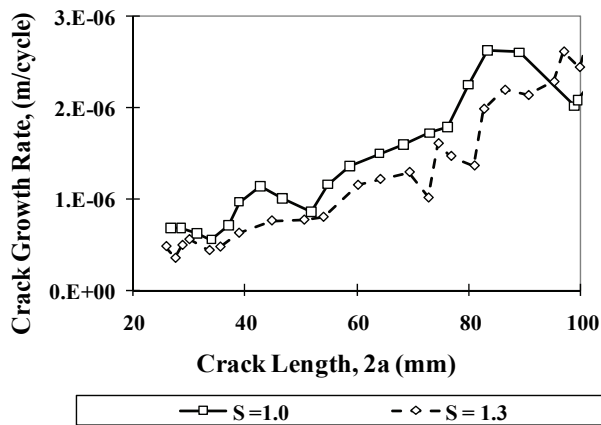
Figure 12: Crack growth rate versus crack length, 6.350 mm, long patch $S=1.0$ versus $S = 1.3$

The effect of the stiffness ratio (1.0 versus 1.3) on the crack growth rates is shown in Figure 12 for the thick repaired panel for the longer patch (102 mm length). The crack growth rates for the higher stiffness ratio of 1.3 were in general slightly lower than those with a stiffness ratio of 1.0 for crack lengths less than 90 mm long, i.e. before any debond occurred. This is expected since higher stiffness ratio increased curvature after bonding (or less bending from thermal stresses), and hence reduced radius of curvature due to the neutral axis offset from application of the load. These effects would decrease the stress intensity factor with increase of stiffness ratio and hence the crack growth rate. Similar phenomenon was also observed with the smaller patch length (51 mm), i.e. the crack growth rates were again less for the higher stiffness ratio patch as shown in Figure 13. Exactly similar

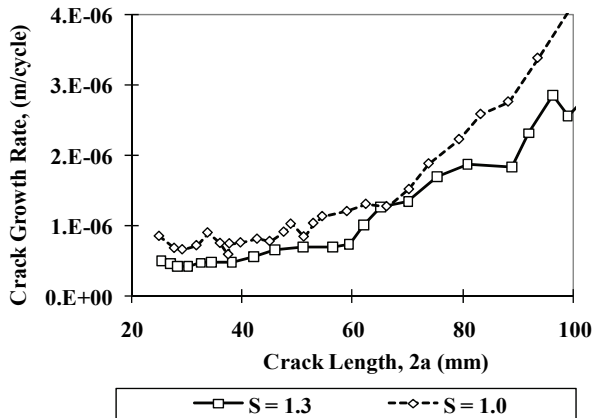
Figure 13: Crack growth rate versus crack length, 6.350 mm, short patch, S = 1.3 versus S = 1.0

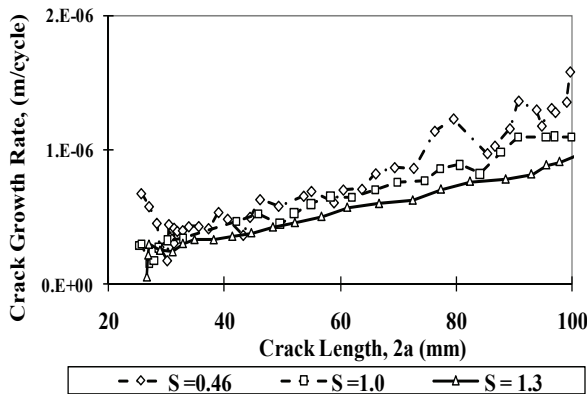
Figure 14: Crack growth rate versus crack length, 3.175 mm, short patch, effect of stiffness

feature was observed with the thin panels (3.175 mm) as shown in Figure 14 where crack growth rates for three stiffness ratios, 0.46, 1.0 and 1.3 are shown for patch length of 51 mm. Finally, Figure 15 displays the same phenomenon with intermediate panel thickness of 4.826 mm with patch length of 51 mm for stiffness ratios: 0.69 and 1.0. Here again higher stiffness ratio provided slower crack growth rate and hence longer fatigue life. Thus, it appears that higher stiffness ratio provides the lower crack growth rate or longer fatigue life for both thin and thick repaired plate for a given patch length. Furthermore, it is interesting to note from Figures 12, 14, and 15 that reduction in the crack growth rate decreased with increase of the panel's thickness for a given increase in stiffness ratio. Thus, it appears that benefit of increasing stiffness ratio depends on thickness of the repaired panel. Hence further studies are also needed in this direction to utilize this benefit in the repaired panels.

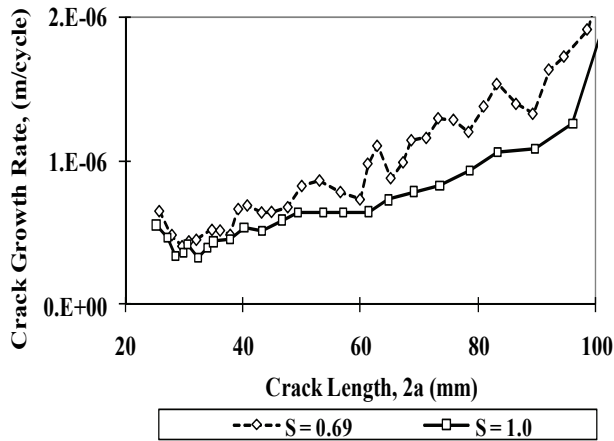
Figure 15: Crack growth rate versus crack length, 4.826 mm, short patch, effect of stiffness ratio

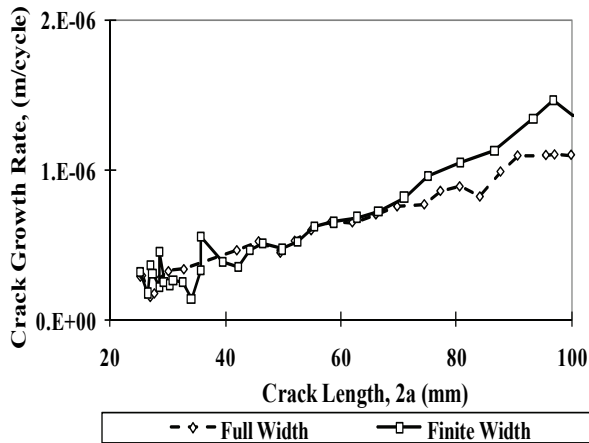
Figure 16: Crack growth rate versus crack length, 6.350 mm, long patch, full width versus finite width

Crack growth rates in the repaired panels with finite width patch, 50 mm wide (i.e. width of the patch up to which thickness was uniform) were compared with counterparts with the full width (153 mm) patch. The crack growth rates of all finite width repairs were equal to their counterparts from the full width repair up to crack length equal to the width of the finite patch, i.e. it was not affected by plate thickness, patch stiffness and patch length. For example, Figure 16 shows the

crack growth rate versus cycle data for repaired thick plate (6.350 mm) for patch length of 102 mm and stiffness ratio of 1.3 for finite width and full width patches. Here the crack growth rates for both patch widths are equal up to crack length equal to uniform width of the finite patch (50 mm). But once the crack propagates into the patch taper region, the crack growth rates for the finite width patch quickly increased and became more than those of the full width patch as expected. Exactly similar feature was seen with the thin panels (3.175 mm) as shown in Figure 17. Thus, there was no effect of the patch width on the crack growth rates up to crack length equal to the uniform width of patch, however wider patch would provide longer crack length which a repaired panel can sustain, and hence overall longer fatigue life.

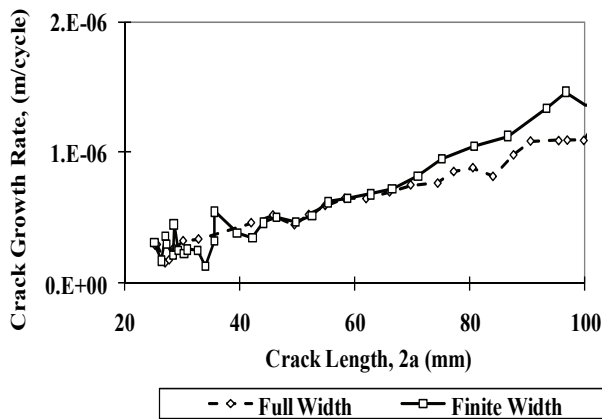
Figure 17: Crack growth rate versus crack length, 3.175 mm, long patch, full width versus finite width

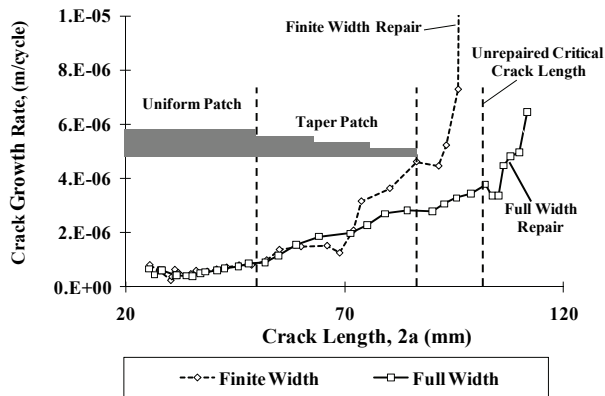
Figure 19: Crack growth retardation at unrepaired critical crack length and change of patch thickness
