Analysis of Crack Expansion and Morphology of Cross-Laminated Timber Planar Shear Test

Yujie Huang¹, Yifan Zhang¹, Zheng Wang^{1,*}, Assima Dauletbe², Yao Lu¹ and Zhaoyu Shen¹

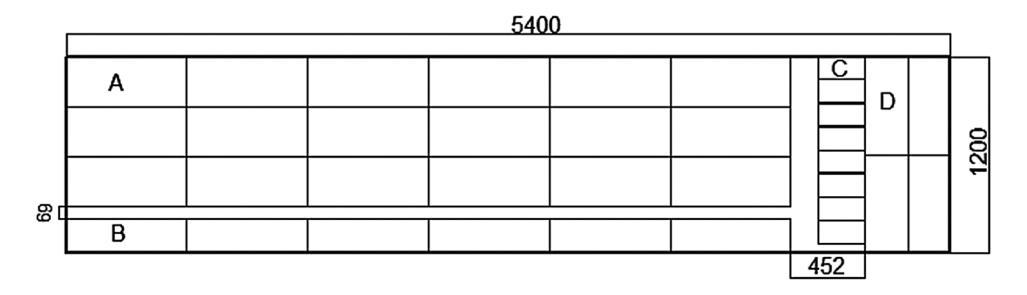
Figure 1: Schematic diagram of the sample sawing

Fig. 1 is the schematic diagram of a single CLT whole board sawing. A1–A3 were rejected because of obvious defects after sawing. Therefore, in this experiment, the C specimen was derived from two CLT whole plates. The D specimens in this study were three-point bending specimens obtained by cutting along the minor strength direction of the CLT. In the test, it was found that when the D specimen was loaded, the adhesive layer cracked in its outermost layer. This was due to the large normal stress that the D specimen born and there was no bearing capacity on the vertical layer. Therefore, the test of D specimen was cancelled.

shear specimen C for the improved planar shear test. The average moisture content of specimens is 9.5% and the average density ρ is 473 kg/m³, as shown in Fig. 1 and Tab. 1, respectively.

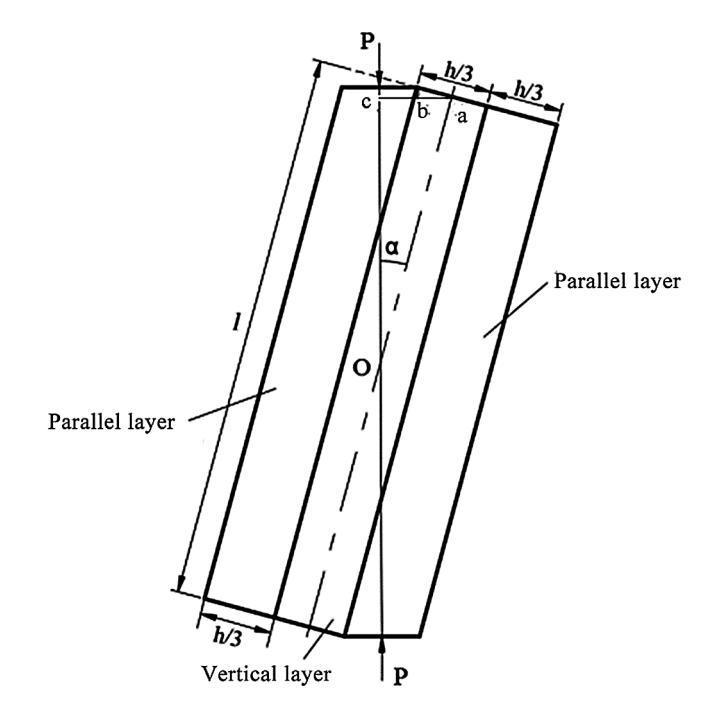
Figure 2: Schematic diagram of the CLT's improved planar shear loading

In Fig. 2, h is the height of the CLT specimen for the improved planar shear test, b is the width, l is the length, and the thickness of parallel layer-vertical layer-parallel layer is h/3 each. The CLT specimen is

coupled with a pair of lead straight forces of equal size and opposite directions, the action line passes through the center of the test specimen, and the action points of the force are the center of the slope cut into the upper end of the left parallel layer, and the center of the bevel cut by the lower end face of the right parallel layer.

It is supposed that the inclination angle of the lead line at the center of the CLT specimen for the improved planar shearing and its centerline is α , in Rt Δ oca, therefore:

$$\sin \alpha = \frac{ac}{oa} = \frac{ab + bc}{oa} = \frac{ab + de}{oa} = \frac{(h/6)\cos \alpha + (h/6)/\cos \alpha}{1/2}$$
$$\left(1 + \frac{1}{\cos^2 \alpha}\right) = \frac{3l}{h} \tan \alpha \quad (2 + \tan^2 \alpha) = \frac{3l}{h} \tan \alpha$$

$$\tan^{2} \alpha - \frac{3l}{h} \tan \alpha + 2 = 0$$
$$\tan \alpha = \frac{3l/h \pm \sqrt{9l^{2}/h^{2} - 8}}{2}$$
(1)

In this article, the size of C specimen is 270 mm × 135 mm × 105 mm, the calculated inclination angle α is 15.04°.

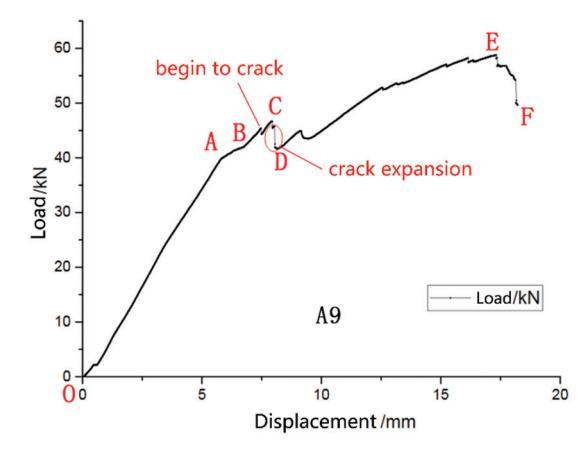
Figure 3: A load-displacement diagram of A9 specimen

The load-displacement diagram of the A9 specimen and its key node results are shown in Fig. 3 and Tab. 2, respectively.

In Tab. 2, the peak load of the E-point is 58.79 kN, the specimen width b is 305 mm and the height h is 105 mm, and these values are substituted in formula (2). That is, the shear strength τ of the A9 specimen is 1.269 N/mm², which is 1.269 MPa.

(1) In the three-point bending test, at the point B on the load-displacement curve (Fig. 3) of the A9 specimen a "shake" appears corresponding to the specimen cracking phenomenon, while in the stage of the load drop (CD stage, the displacement is unchanged, the load suddenly decreases) corresponding cracks suddenly increase. Obviously, on the load-displacement curve of the specimen A, there is a commonality between a "shake" and a fall stage corresponding to the cracking and sudden increase (crack expansion) of the specimen such as A17 and B3, respectively. This phenomenon is different from metals (e.g., steel test specimens) because if the metal is subjected to the three-point bending or compact stretching, the specimen cracks on its load-displacement curve, and once it cracks, the load drops directly, so this reflects the orthotropic anisotropic characteristics of the wood. In the video of the three-point bending test, the specimen is found to crack, but there is no corresponding "shake" phenomenon on the load-displacement curve, it may crack inside, which is not visible on the video. But the sound in the video is used as an auxiliary judgment.

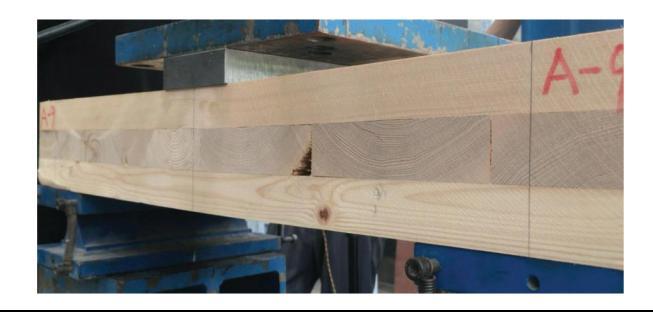
- O–A No change.
- A–B No change.
- B–C The crack appeared on the 14'49" vertical layer in the direction of the annual ring.

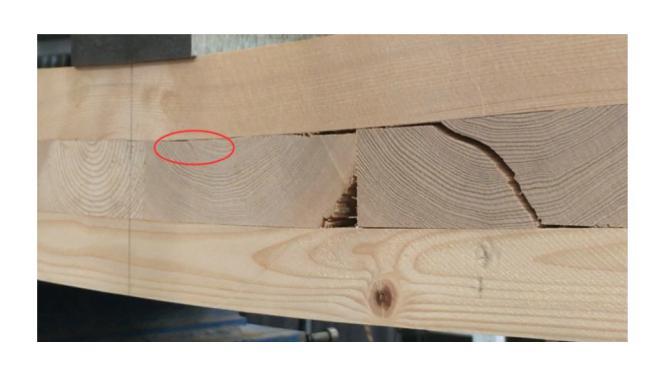
- C–D The crack suddenly increased, 15'57" and ran through the width of the specimen. changed from the initial direction of the ring to 53°, and the mesh cracks appear between the parallel layer and the vertical layer.
- D-E A new small crack appeared in 27'22" the vertical layer near the center of the specimen length.

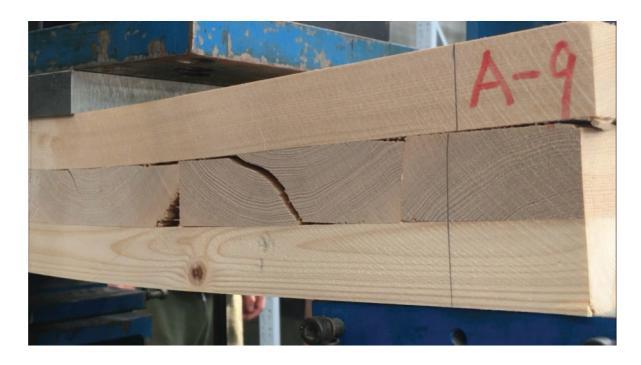
E–F A large displacement occurred between the layers, but no pull damage was observed in the parallel layer.

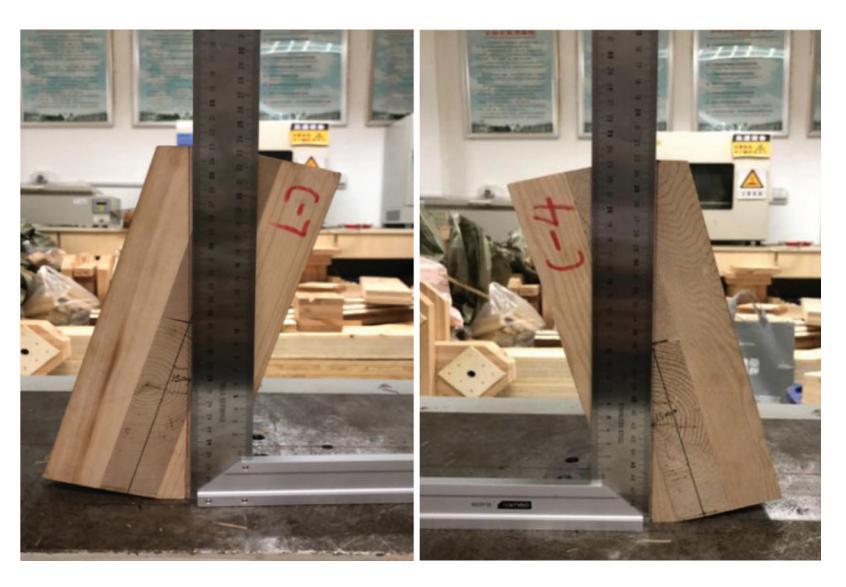
Figure 4: Installation types of C specimen before the test

The shear specimen is placed up and down on the positioning aluminum block, the position is adjusted to ensure that the loading direction passes through the center of the specimen, the loading speed of the plane cut is 0.5 mm/min, using displacement control loading and recording its load-displacement curve. The specimen loading and load-displacement curve will be synchronized by video recording. Fig. 4 shows the two installation types of the C specimen before the test.

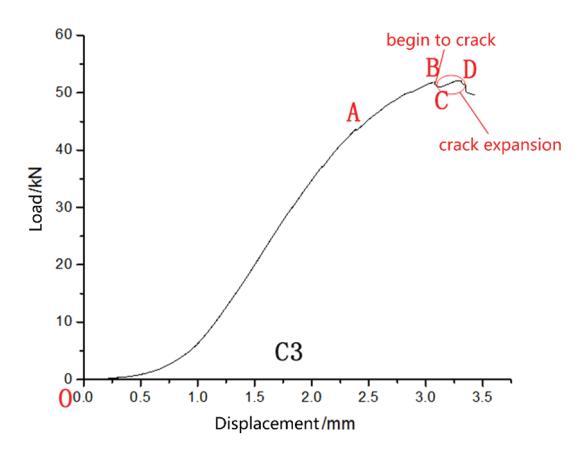
Figure 5: Load-displacement curve of the C3 specimen

In this paper, with its video observation, the relationship between the load-displacement curve of the C3 specimen and the vertical layer cracking, crack expansion, and failure is described by the time node as the contact point. The load-displacement diagram of the C3 specimen and its key node results are shown in Fig. 5 and Tab. 4, respectively.

By the maximum peak load of 52.13 kN substituted into formula (3), the shear strength τ of the test specimen C3 is calculated as 1.38 MPa.

The load-displacement curve of the CLT specimen in the improved planar shear test is different from the load-displacement curve of the three-point bending test, there is a slight "shake" of the falling stage (CD stage of C3 in Fig. 7), and a "shake" crack occurs, reflecting the natural characteristics of the wood. The load-displacement curve of the CLT shear test also exhibits a "shake" in many places corresponding to the production of new cracks.

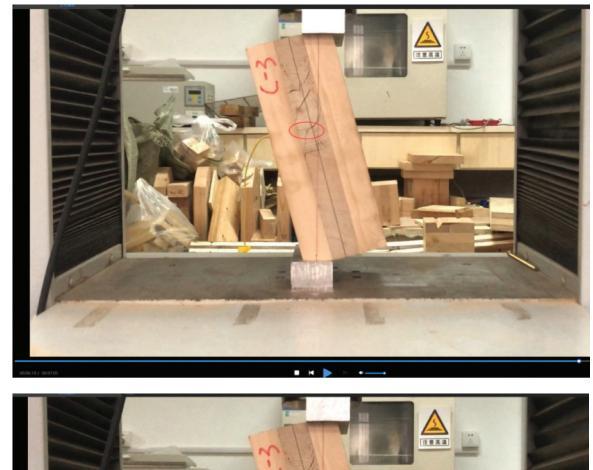
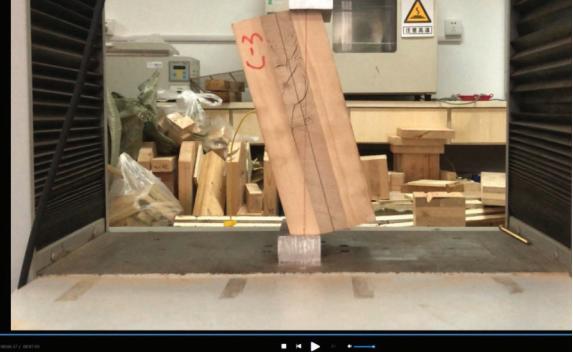
Table 5: Appearance description of C3 specimen of each stage

- B–C The new crack suddenly 6'10" increased along the direction of the annual ring, from which the angle of the crack changes by 45° and continues again along the annual ring and all the way to the layer.
- C–D The cracks in the specimen 15'57" kept increasing.

Table 5 (continued)		
Curve stage	Appearance description of specimens	Cracking time	Video screenshot
D– unload	Both the original crack and the new crack at this stage increased until the specimen was completely destroyed.

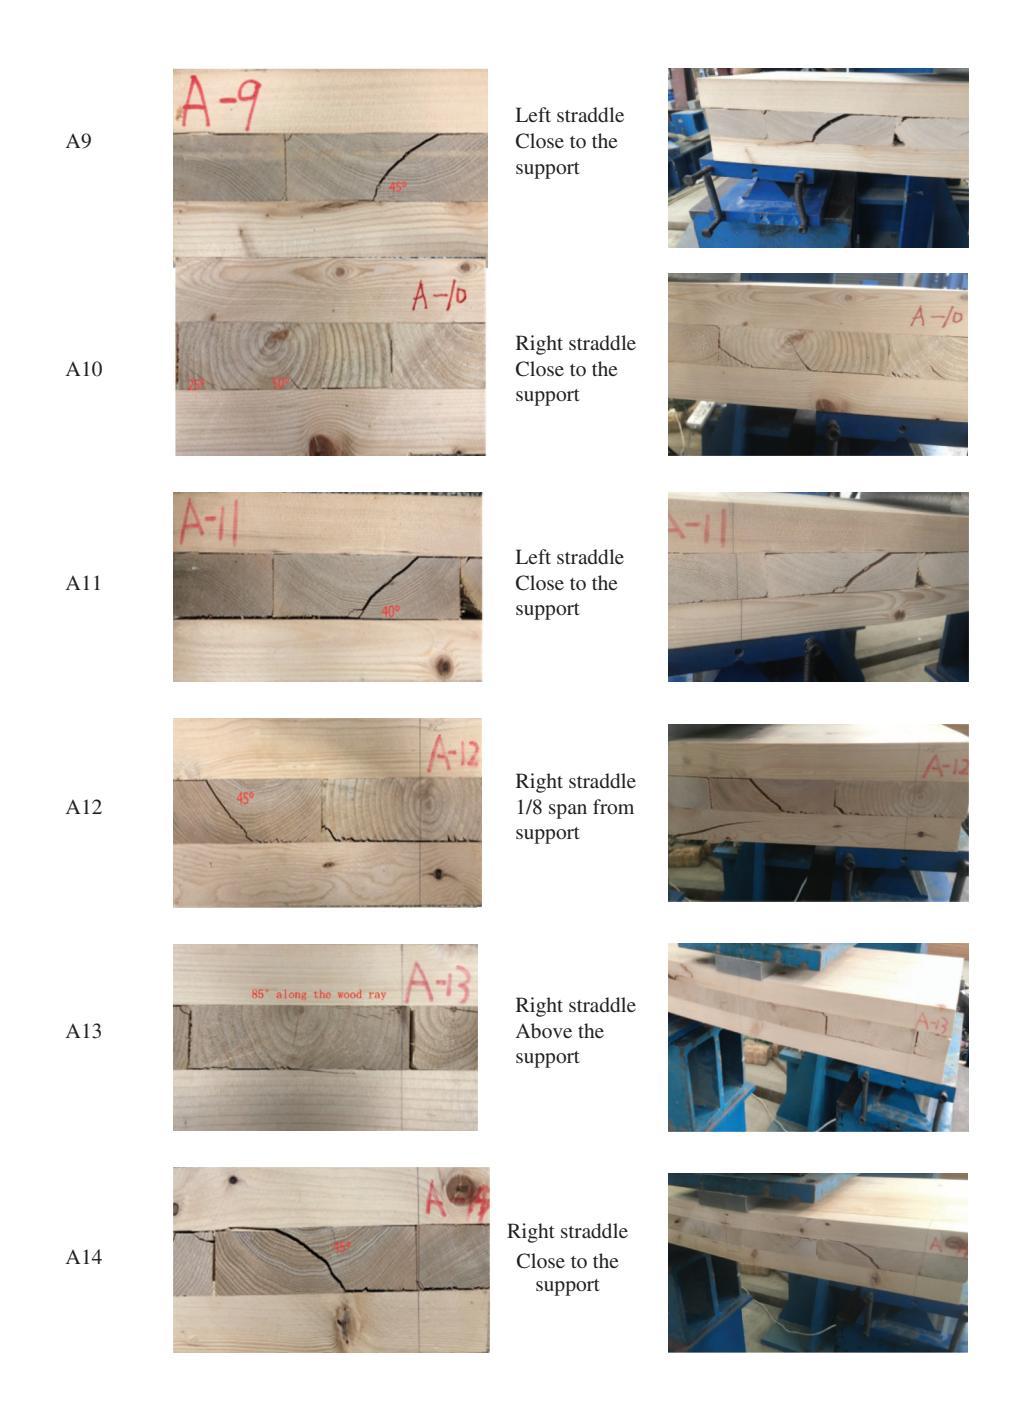
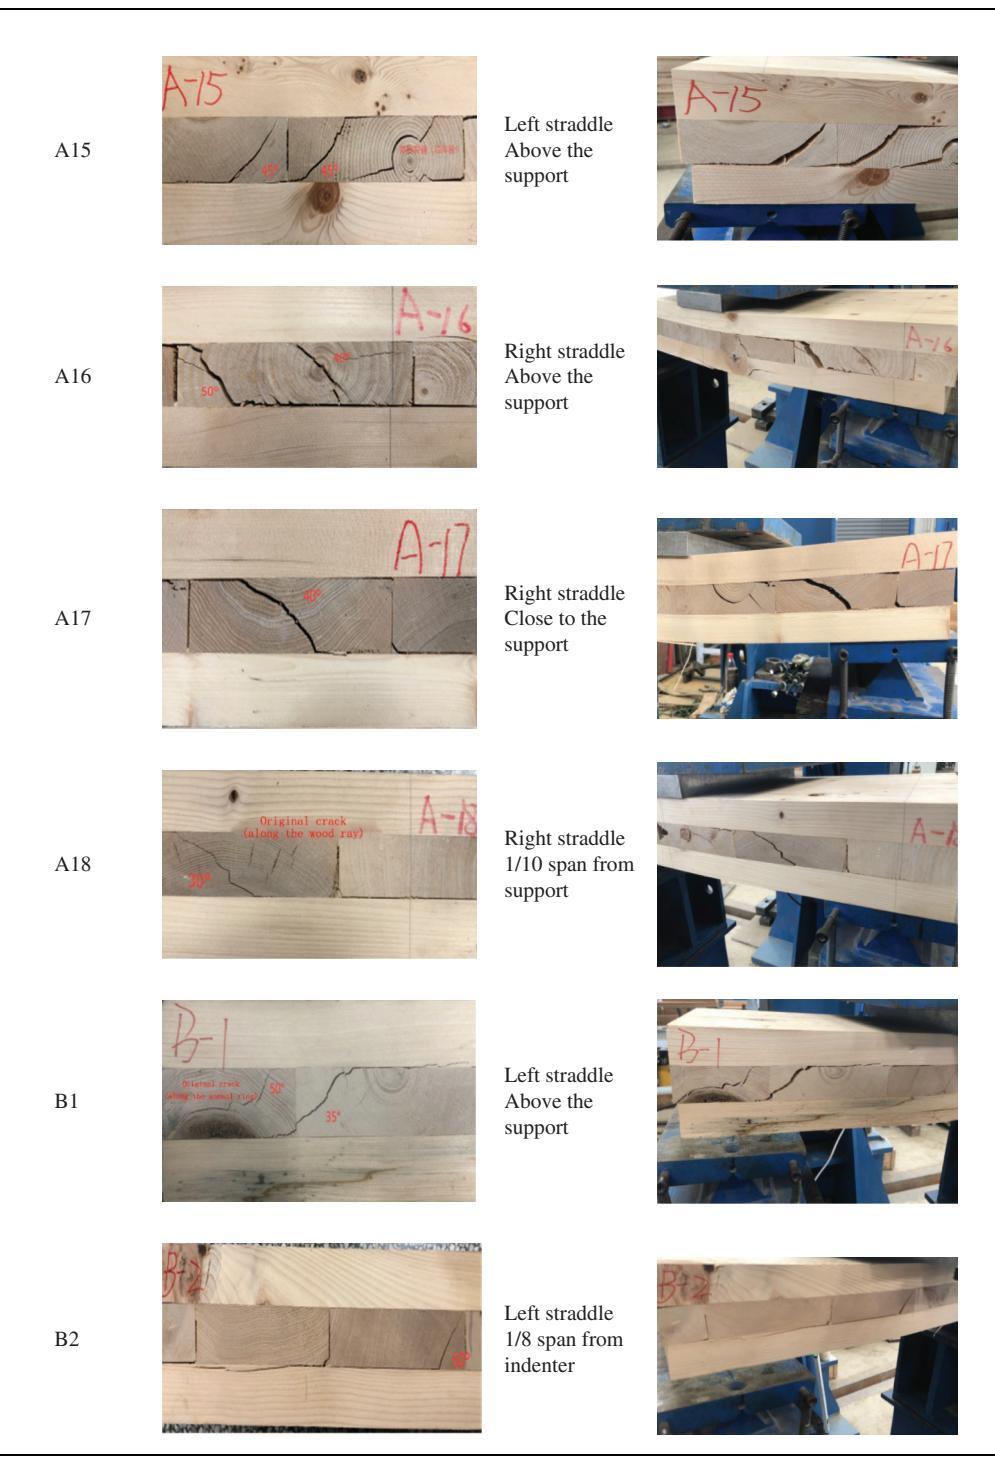
Table 6: Crack morphology and crack orientation of CLT three-point bending specimen

The crack morphology and the azimuth angle of the cracking surface of the CLT three-point bending specimens and the plane shear specimens are shown in Tabs. 6 and 7, respectively. Interlayer cracking, there must be wood chips on the cracked surface, otherwise the glue layer is cracked. In the interlayer cracking, if the wood chips are on the vertical layer, it is the shear failure of the vertical layer. The reason is that the shear stress on the cracking surface is the largest or close to the largest, and the normal stress is small. On the contrary, if the wood chips are on the parallel layer, it is the shear failure of the parallel layer along the grain.

Among the CLT three-point bending specimens (A and B), the specimens where the crack did not penetrate the vertical layer are: A7, A8, A10, A13, B4. The vertical layers of other specimens were all penetrated by cracks. The crack angle and shape are shown in Tab. 6.

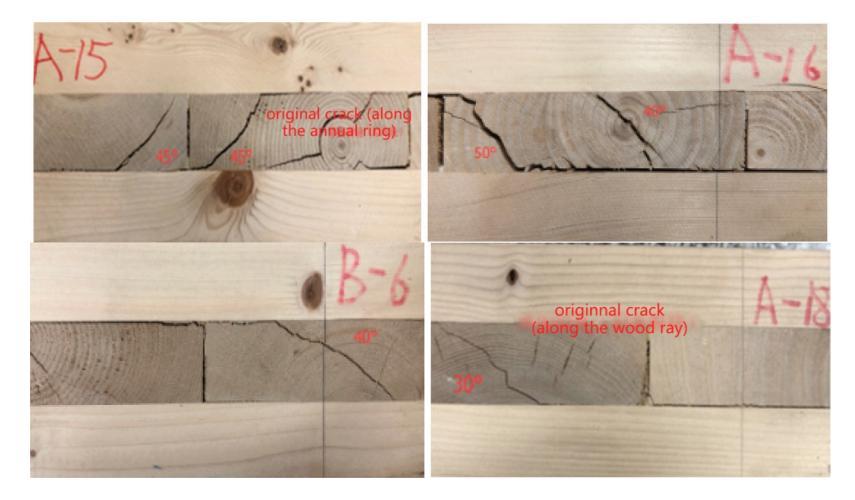
Figure 6: Cracking appearance on a vertical layer that is neither ring shake nor heart shake

The cracking morphology of the wood grain on the cross-section of wood is usually divided into two types: ring shake and heart shake [25]. Ring shake includes circular shake (along the annual ring) and chord cracks (along the tangent direction of annual rings). Heart shakes refer to cracking along the wood ray direction. This study showed that in addition to ring shaking and heart shaking, the cross-section of the vertical CLT layer under mechanical stress has a new crack morphology that is neither ring shake nor heart shake, such as: A15 (45°), A16 (50°), B6 (40°), A18 (30°) and A10 (25°) (Note: the azimuth angle measured from the cracked surface is in brackets) (Fig. 6).

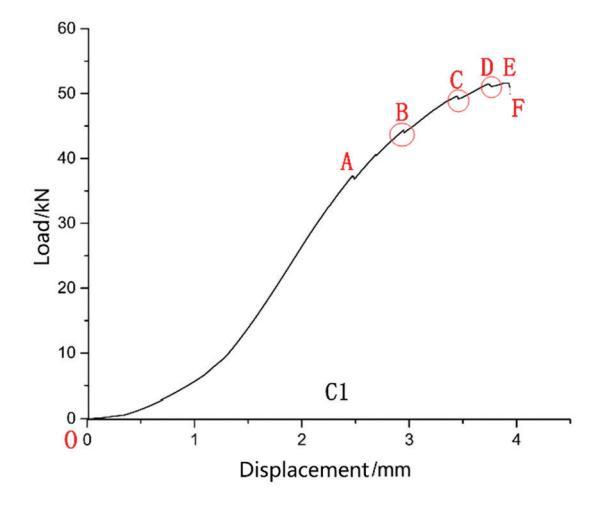
Figure 7: Load displacement curve of CLT shear specimen C1

The load-displacement curve of the specimen C1 also shows a "shake" phenomenon several times (Figs. 7A–7D), from B, C, D, from the corresponding time nodes in the vertical layer surface of the specimen a newly formed crack can be observed, as shown in Tab. 9. Although no new cracks formed at

a "shake" in the vertical layer surface of the specimen, but a "click" sound can be heard from the issued video, indicating that the internal wood fiber cracks.
