Characteristics on Seawater Corrosion of Intensely Weathered Surrounding Rock of Subsea Tunnel

Keywords: Subsea tunnel; seawater corrosion; deterioration of surrounding rock; strength attenuation; damage

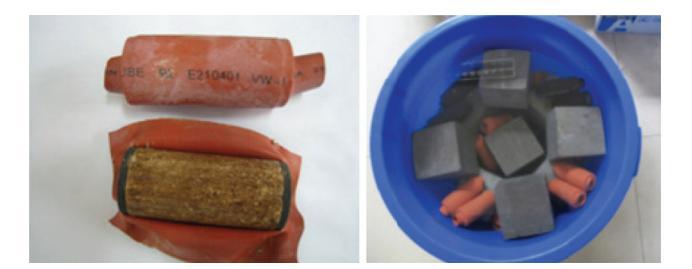
Figure 1: Remolded samples of intensely weathered granite

A total of 90 samples of intensely weathered granite were prepared and divided into five groups on average. The filter study was placed on both ends of the sample, and the porous stones were added on the outside of the filter study, as shown in Fig. 1. After the samples were sealed with heat shrink tube, they

The rock cores were collected in the weathered trough with the moisture content and density unchanged, and then they were mashed, mixed and pressed into 90 remolded samples with the diameter of 38 mm, height of 76 mm and density of 2.08 g/cm³. The rosin alcohol solution was added to the remolded samples to help cementing, so that they would not scatter when soaked and their strength would not be affected. When the rosin alcohol solution was prepared, the solute was 130 g rosin, and the solvent was 132,0 g 99% alcohol. Ten samples were remodeled at a time with 50 g rosin alcohol solution added, i.e., one sample contained about 10 g rosin alcohol solution.

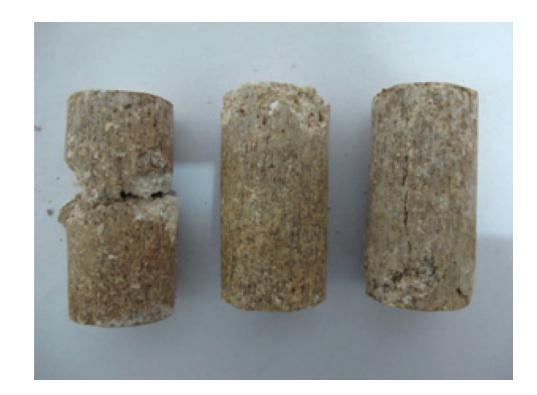
Category I: the samples in the process of loading generated relatively large radial expansion, the central part continuously peeled off, and the pressure section continued to decrease, resulting in fracture in the middle, as shown in the left sample in Fig. 2. This phenomenon is primarily resulted from the low strength of intensely weathered granite. Under completely dry condition, the cohesion between the particles was very small; the samples would collapse in the case of expansion deformation and lose its strength finally.

Figure 2: Failure modes of uniaxial compression test after soak in distilled water

Category II: the samples in the test generated a number of splitting failure sections, and due to low tensile strength of intensely weathered granite, the failure section was tension-based, as shown in the right sample in Fig. 2.

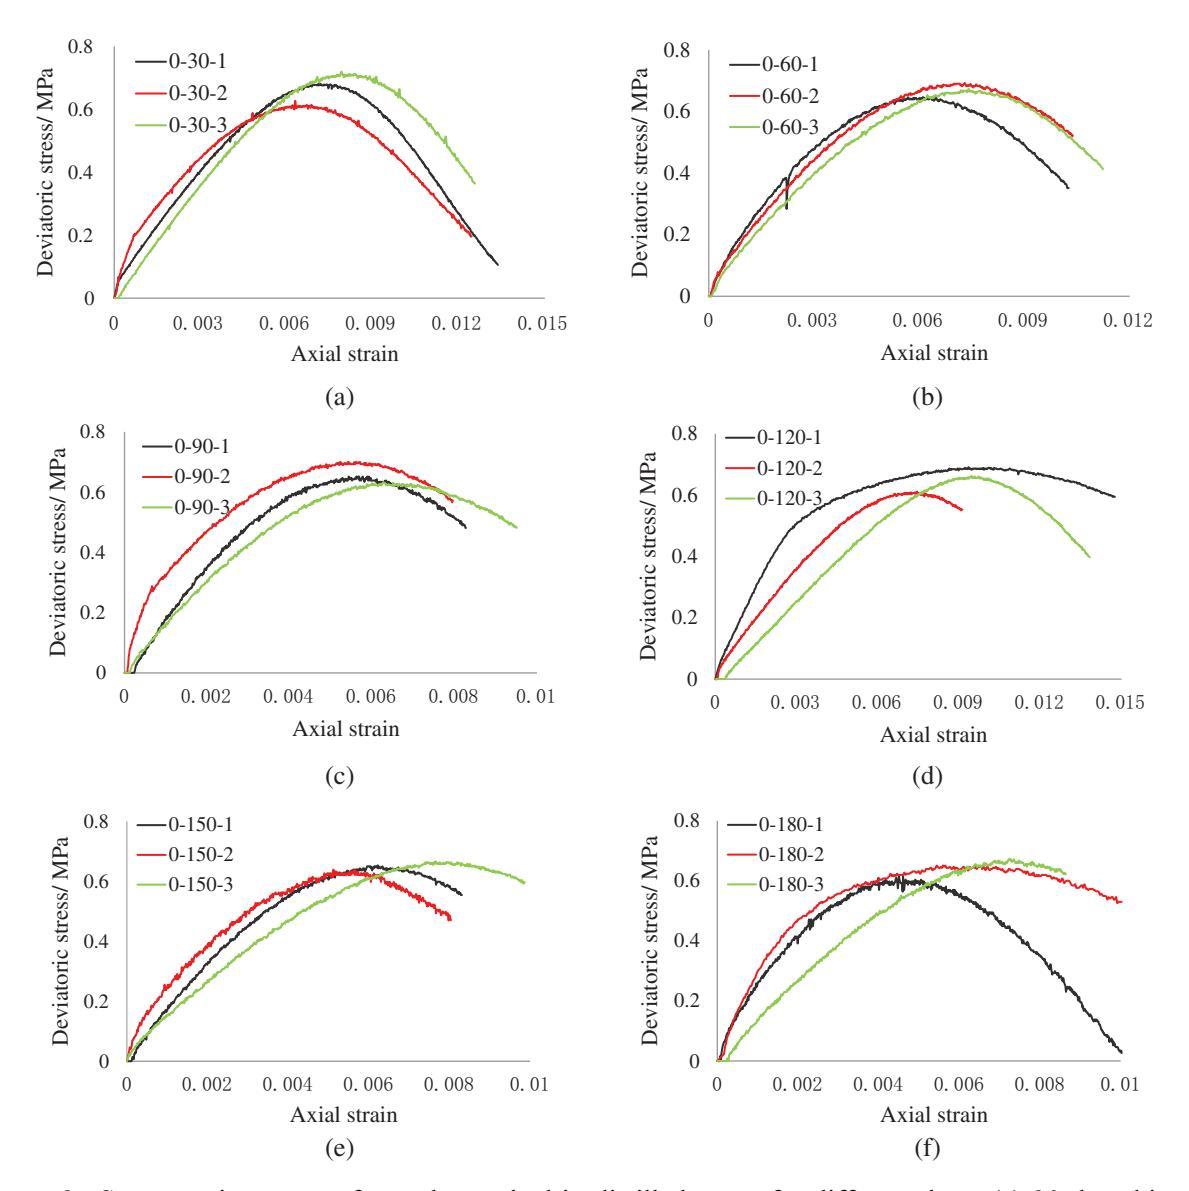
After soaked in distilled water for different days, the curve of relationship between the deviatoric stress and axial strain was obtained from uniaxial compression test, as shown in Fig. 3. The numbering rule of rock samples was "0-30-1", where "0" means that the corrosive solution is 0-time concentration of seawater (distilled water), "30" means soak for 30 days, and "1" means No. 1 rock sample in the group.

Figure 3: Stress-strain curves of samples soaked in distilled water for different days. (a) 30 d soaking in distilled water. (b) 60 d soaking in distilled water. (c) 90 d soaking in distilled water. (d) 120 d soaking in distilled water. (e) 150 d soaking in distilled water. (f) 180 d soaking in distilled water

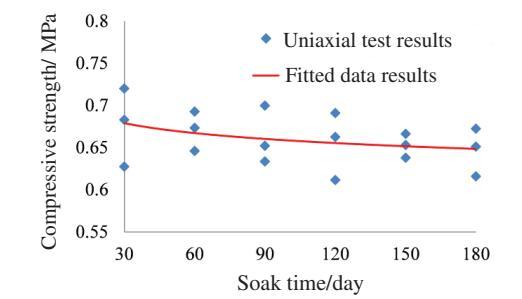
As shown in Fig. 4, the fitted parameters are $\sigma_0 = 0.737 MPa$ and $\alpha_w = 0.0231$, that is, the attenuation equation of compressive strength of rock samples over soak time is:

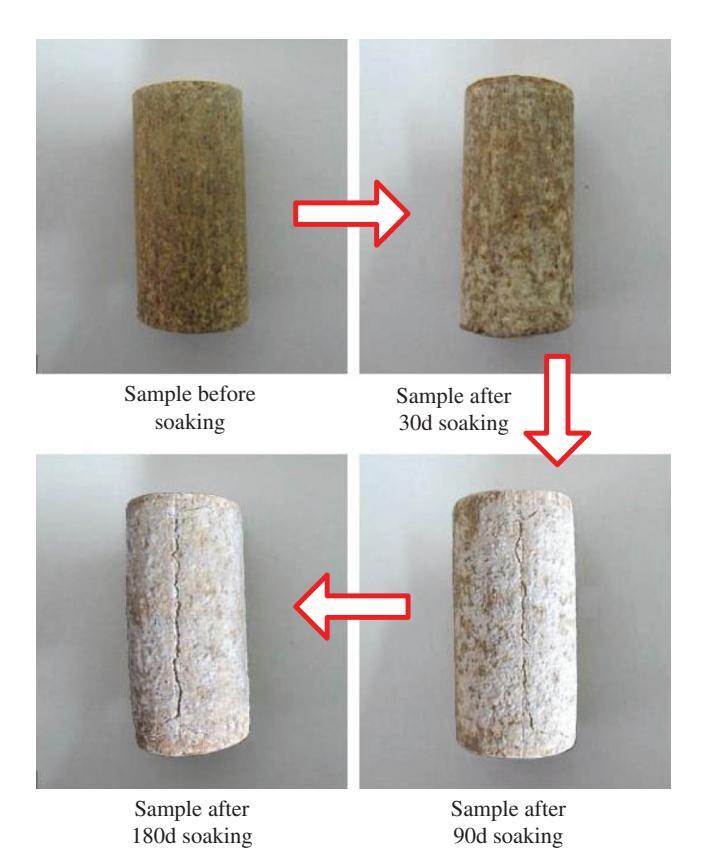
The surface of the samples before seawater corrosion was yellowish brown. As shown in Fig. 5, after the samples were corroded by seawater and baked at 105°C for 48 hours till constant weight, the results showed that: (1) After 30 days of soaking, white crystals appeared on the surface, and the samples had a little radial expansion after dried; (2) After 90 days of soaking, a large number of white crystals were formed on the surface, and the samples cracked after dried at 105°C; (3) After 180 days of soaking, the expansion deformation was more obvious and the crack widened.

Figure 5: Forms of samples after corrosion and drying

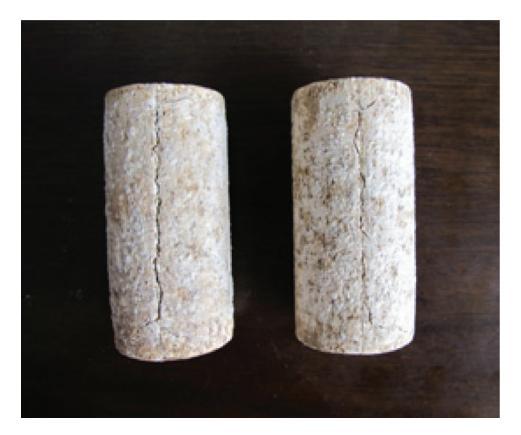
A majority of remolded samples after soaked in artificial seawater had splitting failure from top to bottom after subject to the uniaxial compression test, and there were a large number of white crystals on the surface and even in the splitting cracks, as shown in Fig. 6.

Figure 6: Failure modes of remolded samples after soaked in artificial seawater and subject to uniaxial compression test

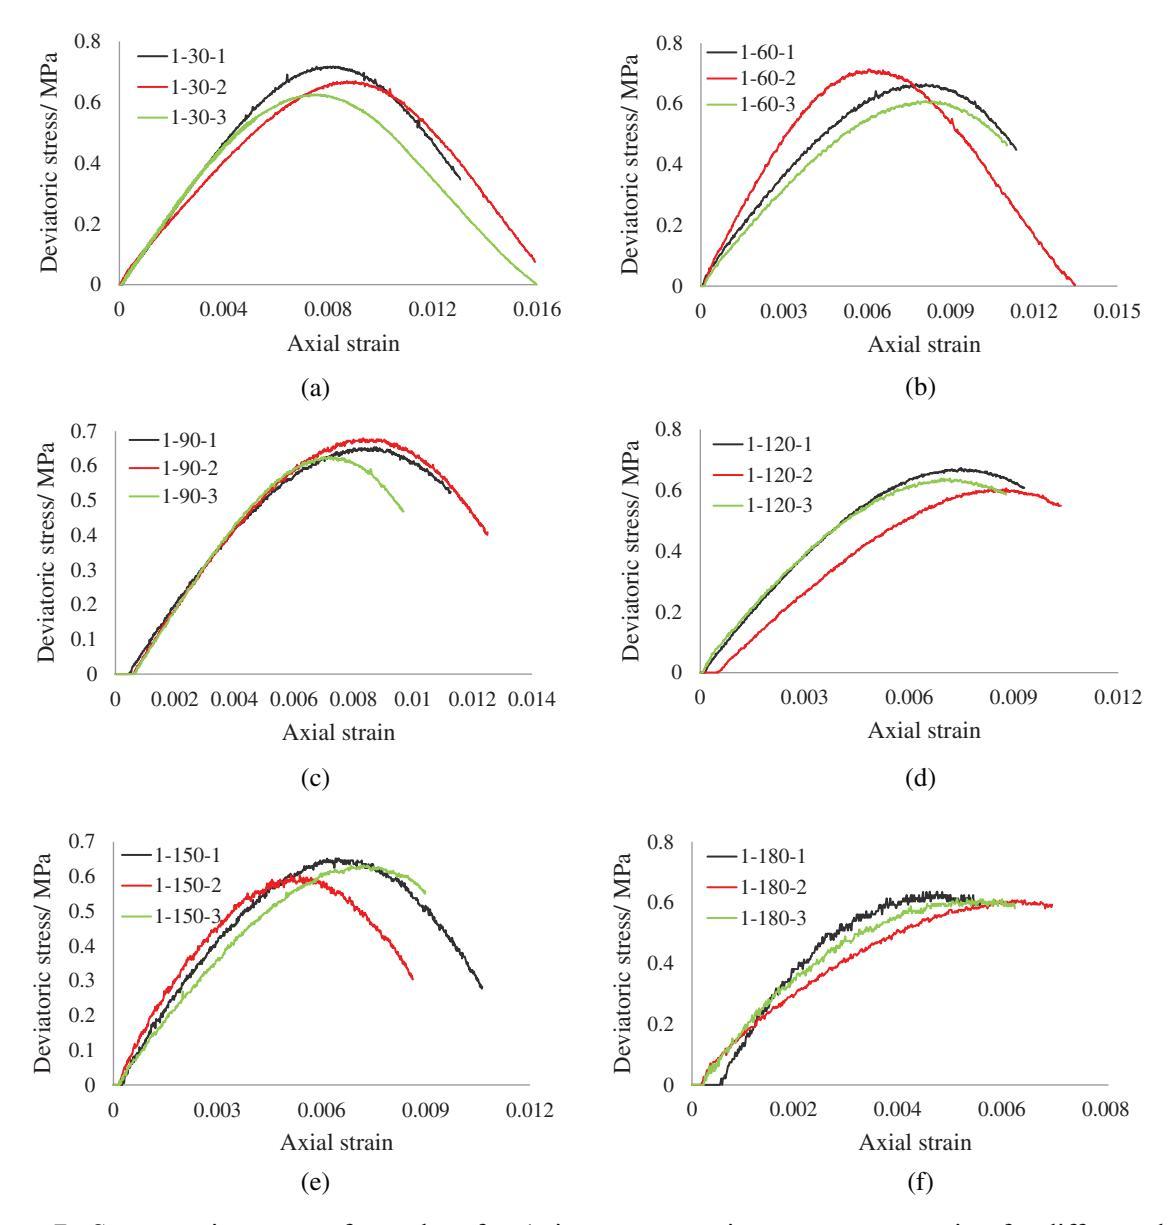
After soaked in 1-time concentration seawater, the uniaxial compressive strength of the sample decreased with the increase of corrosion time, which decreased by 8.58% from 0.671 MPa at d30 to 0.618 MPa at d180, as shown in Tab. 4 and Fig. 7.

Figure 7: Stress-strain curves of samples after 1-time concentration seawater corrosion for different days. (a) 30 d corrosion in 1-time concentration seawater. (b) 60 d corrosion in 1-time concentration seawater. (c) 90 d corrosion in 1-time concentration seawater. (d) 120 d corrosion in 1-time concentration seawater. (e) 150 d corrosion in 1-time concentration seawater. (f) 180 d corrosion in 1-time concentration seawater

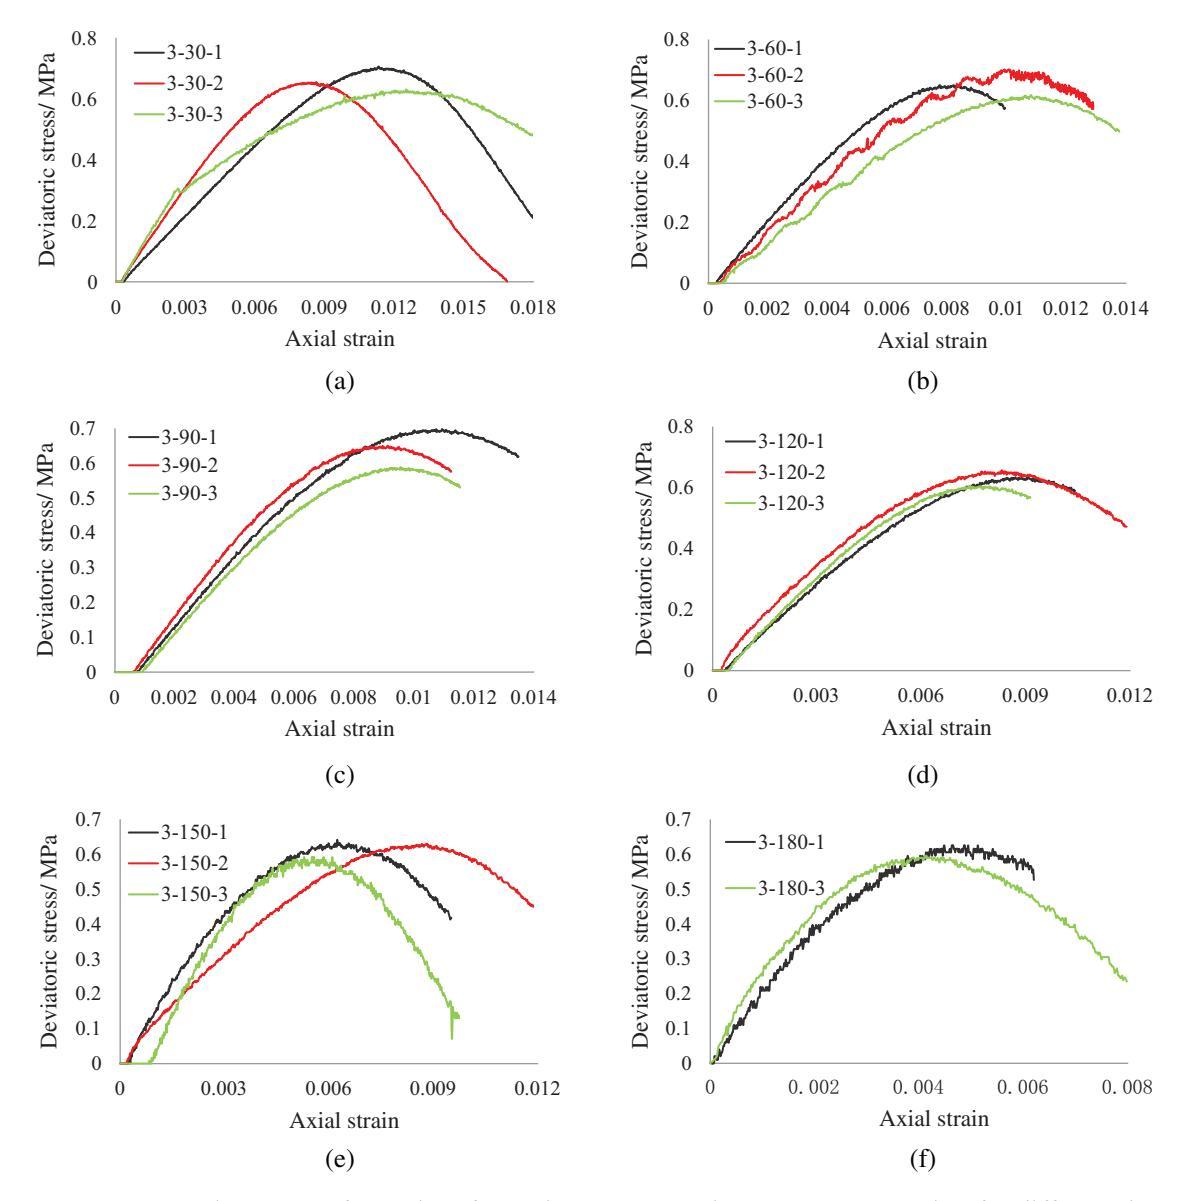
After soaked in 3-time concentration seawater, the uniaxial compressive strength of the sample decreased with the increase of corrosion time, which decreased by 8.67% from 0.664 MPa at d30 to 0.611 MPa at d180, as shown in Tab. 5 and Fig. 8.

Figure 8: Stress-strain curves of samples after 3-time concentration seawater corrosion for different days. (a) 30 d corrosion in 3-time concentration seawater. (b) 60 d corrosion in 3-time concentration seawater. (c) 90 d corrosion in 3-time concentration seawater. (d) 120 d corrosion in 3-time concentration seawater. (e) 150 d corrosion in 3-time concentration seawater. (f) 180 d corrosion in 3-time concentration seawater

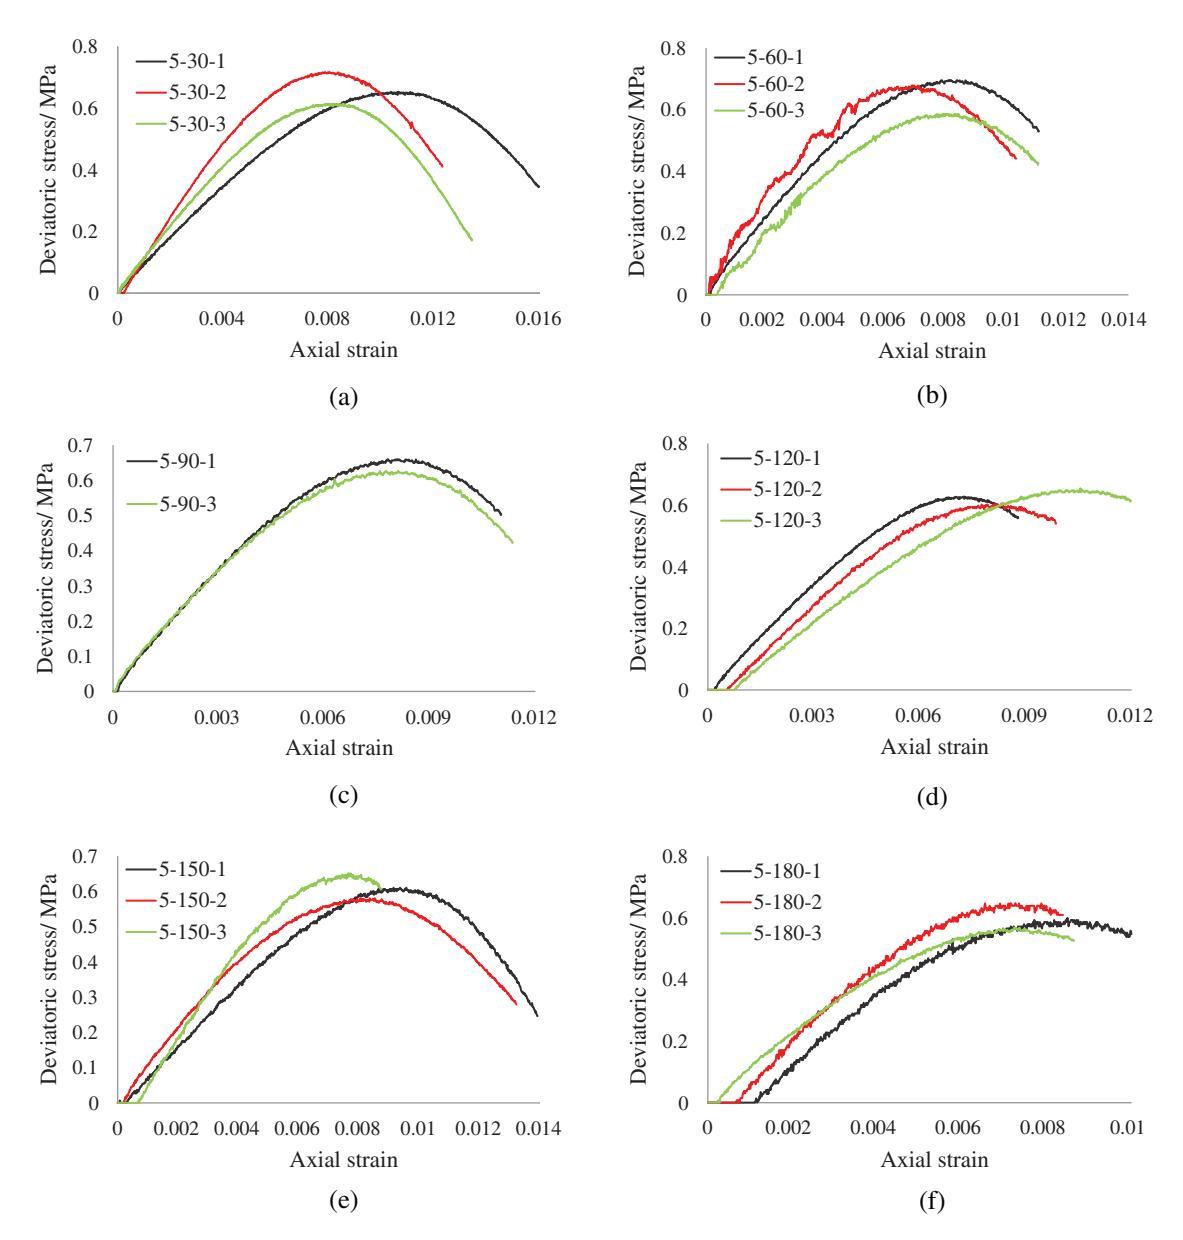
After soaked in 5-time concentration seawater, the uniaxial compressive strength of the sample decreased with the increase of corrosion time, which decreased by 9.26% from 0.661 MPa at d30 to 0.605 MPa at d180, as shown in Tab. 6 and Fig. 9.

Figure 9: Stress-strain curve of samples after 5-time concentration seawater corrosion for different days. (a) 30 d corrosion in 5-time concentration seawater. (b) 60 d corrosion in 5-time concentration seawater. (c) 90 d corrosion in 5-time concentration seawater. (d) 120 d corrosion in 5-time concentration seawater. (e) 150 d corrosion in 5-time concentration seawater. (f) 180 d corrosion in 5-time concentration seawater

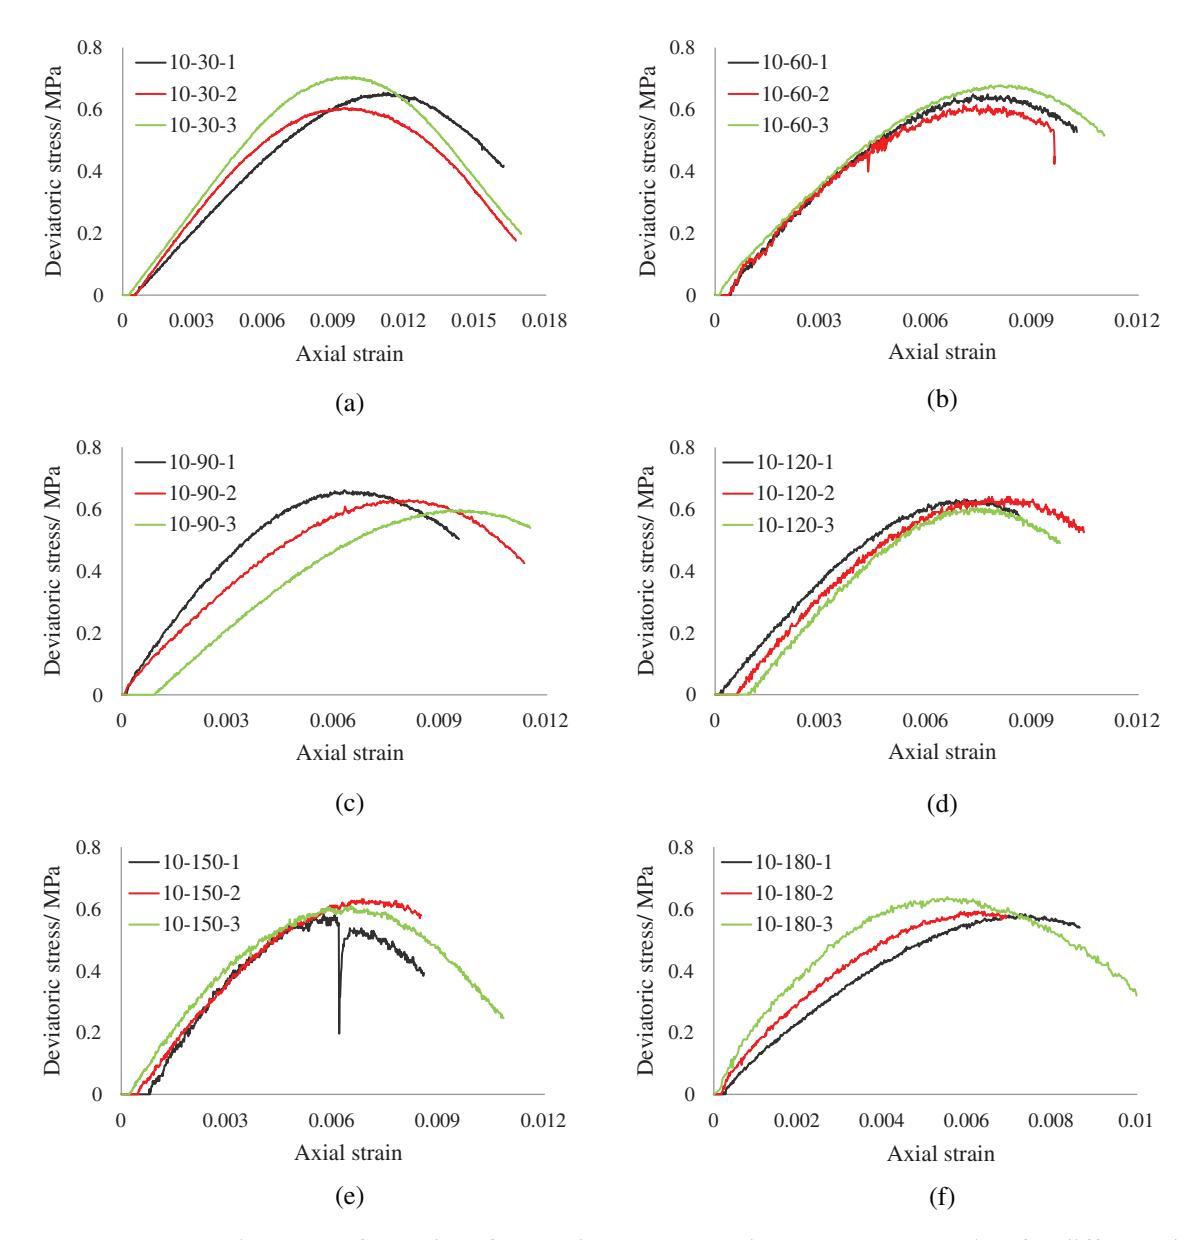
After soaked in 10-time concentration seawater, the uniaxial compressive strength of the sample decreased with the increase of corrosion time, which decreased by 8.44% from 0.655 MPa at d30 to 0.604 MPa at d180, as shown in Tab. 7 and Fig. 10.

Figure 10: Stress-strain curve of samples after 10-time concentration seawater corrosion for different days. (a) 30 d corrosion in 10-time concentration seawater. (b) 60 d corrosion in 10-time concentration seawater. (c) 90 d corrosion in 10-time concentration seawater. (d) 120 d corrosion in 10-time concentration seawater. (e) 150 d corrosion in 10-time concentration seawater. (f) 180 d corrosion in 10-time concentration seawater.

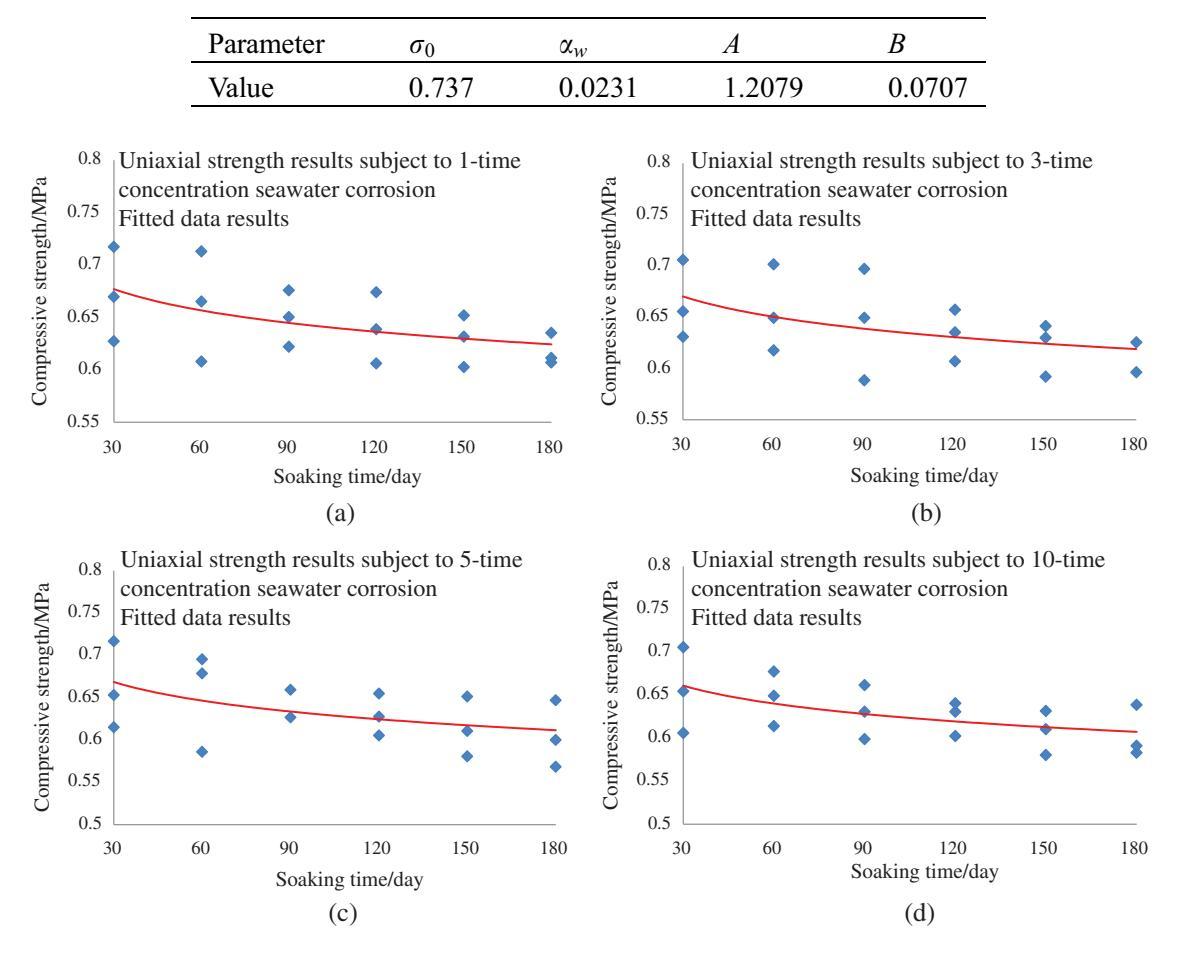
The fitted values of parameters are shown in Tab. 8 and Fig. 11, that is, the attenuation equation of the compressive strength of rock samples over seawater corrosion time are [23-24]:

Figure 11: Curve of relationship between uniaxial compressive strength and soak time. (a) 1-time concentration seawater. (b) 3-time concentration seawater. (c) 5-time concentration seawater corrosion. (d) 10-time concentration seawater corrosion

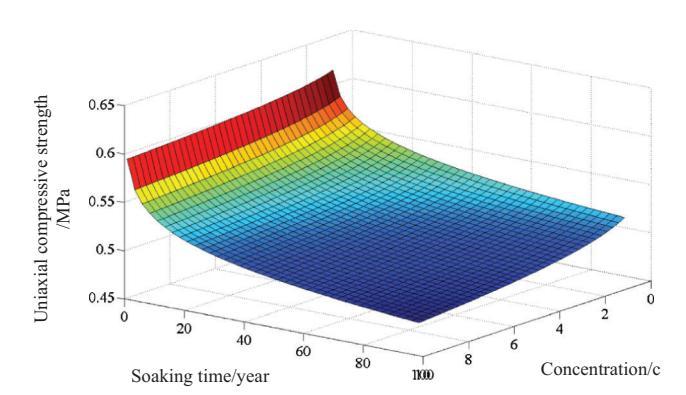
Fig. 12 shows the curved surface of strength attenuation of intensely weathered granite. It is more intuitive to see the influence of seawater concentration and corrosion time on the uniaxial compressive strength.

Figure 12: Curved surface of strength corrosion of intensely weathered granite

Four sections were obtained in Fig. 12 along the concentration axis with c = 1, c = 3, c = 5 and c = 10 set respectively so that four curves were got as shown in Fig. 13. It can be seen that the prediction curves of different concentrations conform to the test data, which indicates that the strength prediction model well reflects the strength deterioration of the intensely weathered granite after long-term soaking in seawater, and as a result, the long-term strength of rock under seawater corrosion can be estimated.

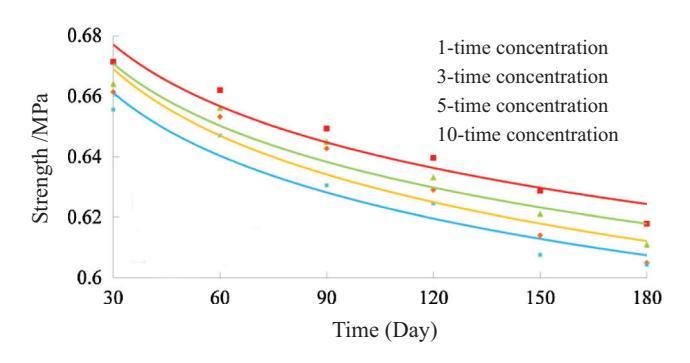
Figure 13: Strength corrosion curve of intensely weathered granite

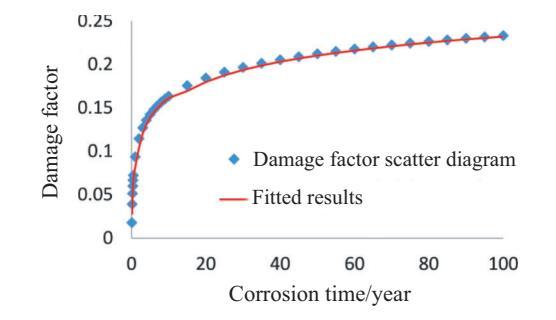
The fitted results of parameters are $\gamma = 12.236$ and $\lambda = -0.0371$ from Fig. 14, that is, the attenuation equation of compressive strength of rock samples over soak time is:

Figure 14: Curve of chemical damage factor evolution equation of intensely weathered granite
